ENDURANCE TESTING OF COMPOSITE REINFORCED WELDED ALUMINUM STRUCTURES

Larry Cercone and Franz Worth
Air Logistics Corporation, Pasadena, CA 91107

ABSTRACT

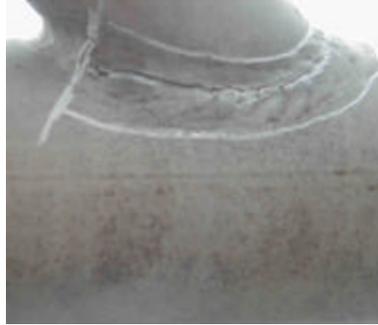
structures, in some cases causing a structural failure (Figure 2). There have been several conventional methods, such as a steel cable sling or splice plates, employed to prevent collapse of the damaged structure, but there was no way to restore the original strength of the connection (Figure 3). During the past three years Air Logistics Corporation, in conjunction with the New York State Department of Transportation, Utah Department of Transportation, and the University of Utah, has developed an FRP repair system that can be used to bring the strength of a cracked connection back to its original design values and in some cases exceeding those original values.

Figure 2. Cracked Weld

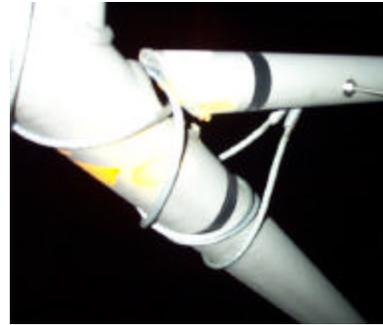
Figure 3. Cable Repair

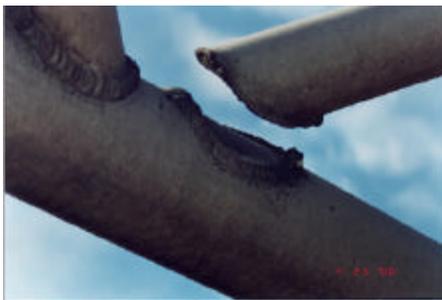
The welded joints crack at the connection between the interior chord and the main longitudinal chord (Figures 4 & 5). Typically, the crack follows the weld and remains completely within the weld pool or, due to poor penetration of the weld into the base metal, propagates along the interface between the weld and the base metal. Poor penetration of the weld into the base metal actually prevented some of the cracks from propagating into the base metal. In some isolated cases the cracks extend into the interior chord and, in extreme cases, can also extend into the main chord itself.

Figure 4. Typical Weld Failure

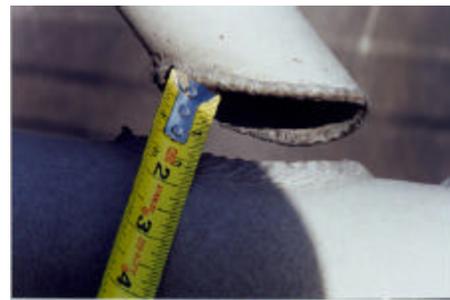
Figure 5. Severe Weld Separation

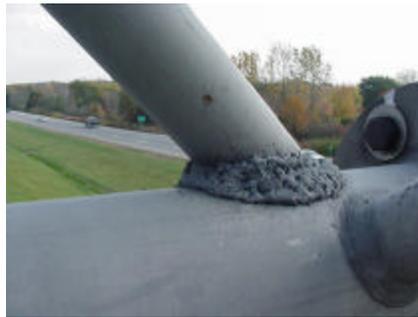
During the original construction of the sign structures the welded elements were not stress relieved. Also, the elements were not stress relieved during installation. Thus, they could have warped and caused a misalignment with the horizontal supports. This condition may have required the installation crew to pull, push, or torque the truss element into position, causing additional stress to be introduced into the system. These additional unforeseen stresses eventually lead to the crack development. In addition to this theory, it has been noted that fatigue design was not required in the NYSDOT Design Manual for Aluminum Overhead Sign Structures, 1968. Also, there was no shop inspection being conducted prior to 1999. However, all new designs, both span and cantilever type structures, account for fatigue. So, although construction problems may have had existed, there were also obvious quality control issues, as evidenced in the sloppy welds, as well as unanticipated fatigue considerations (Figure 6).

Figure 6. Poorly Welded Joint

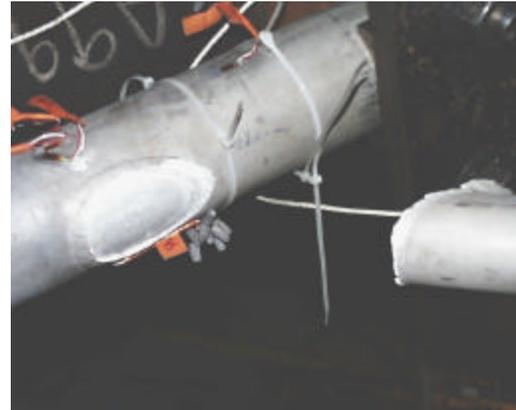
Figure 11. Typical aluminum connection failure during testing.

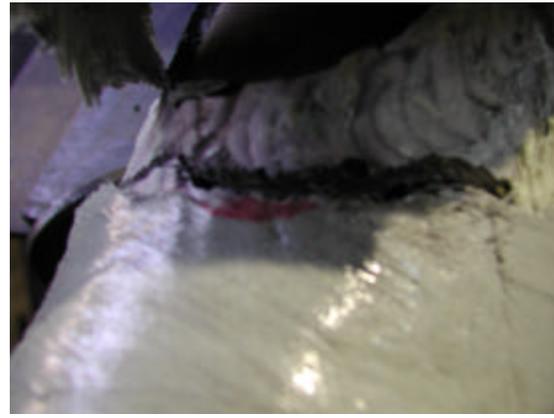
Figure 13. Typical Fatigue Fracture
