Research Overview Of Composite Materials in Pipelines

Third Annual Composite Repair Users Group Workshop
Hilton Garden Inn NW America Plaza (Houston, Texas)
Thursday, September 26, 2013

Stress Engineering Services, Inc.

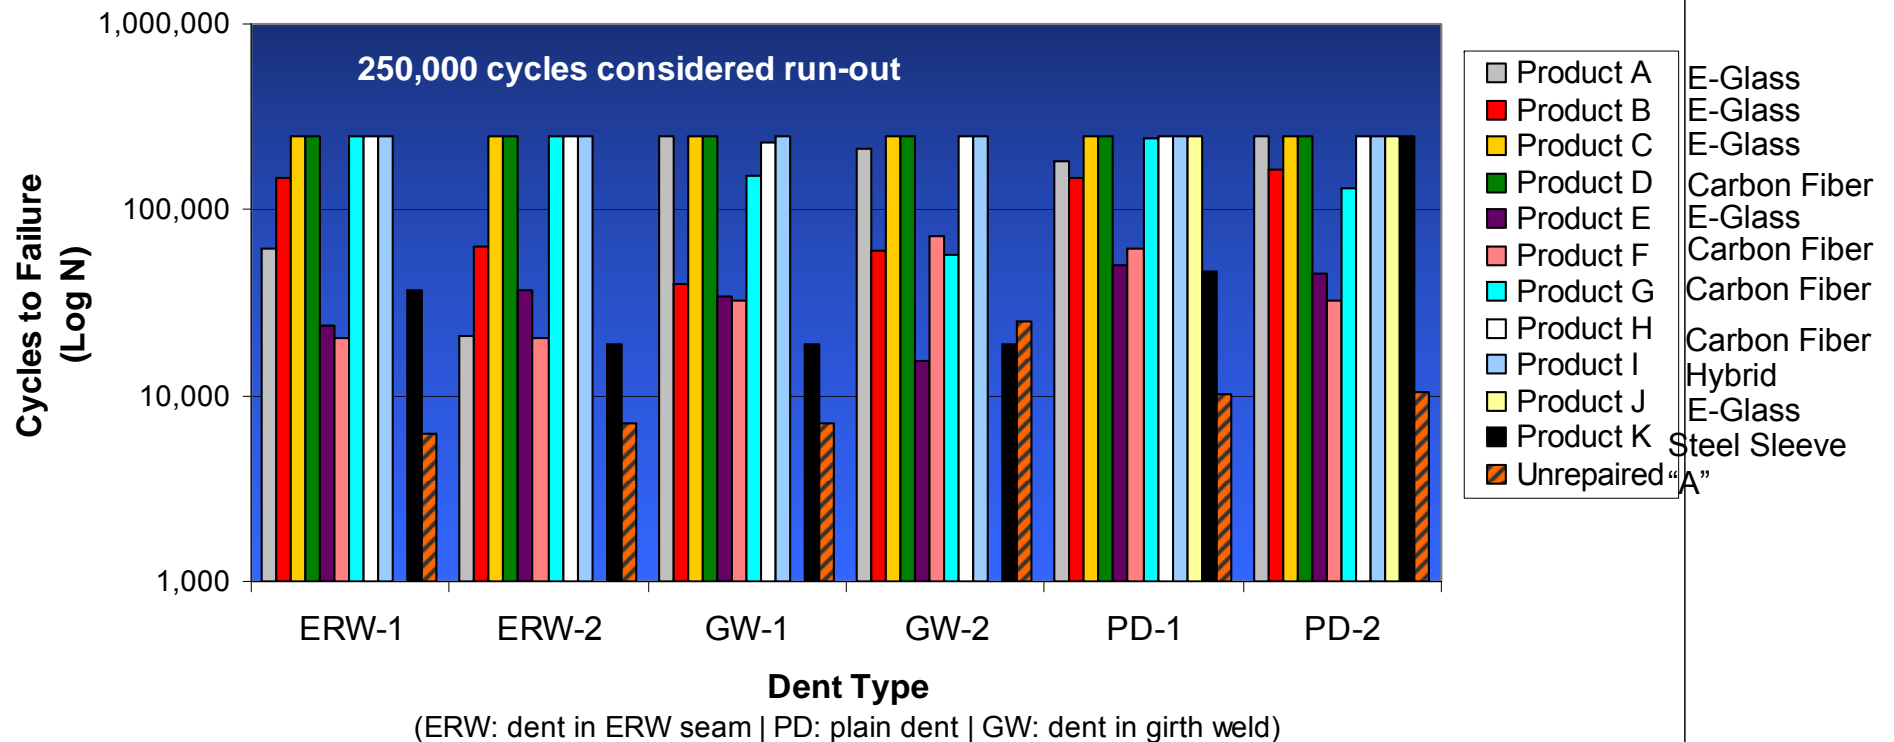
Cycles to Failure for Composite Repaired Dents

Dents initially 15% of OD installed on a 12.75-inch x 0.188-inch, Grade X42 pipe using a 4-inch end cap. Dents installed with 72% SMYS pressure in pipe and cycled to failure at $\Delta\sigma = 72\%$ SMYS.

- PRCI-sponsored program (25%) along with co-funding from manufacturers (75%)
- Ten (10) repair systems participating in study
 - 2 rigid coil system (one E-glass & one steel)
 - 3 carbon systems
 - 4 E-glass systems
 - 1 Steel Sleeve
- One unrepaired test sample served as baseline
- 68 total dents in study
- Intent was to validate composite materials for repairing dents subject to cyclic service

Cycles to Failure – Not all Systems Created Equal!

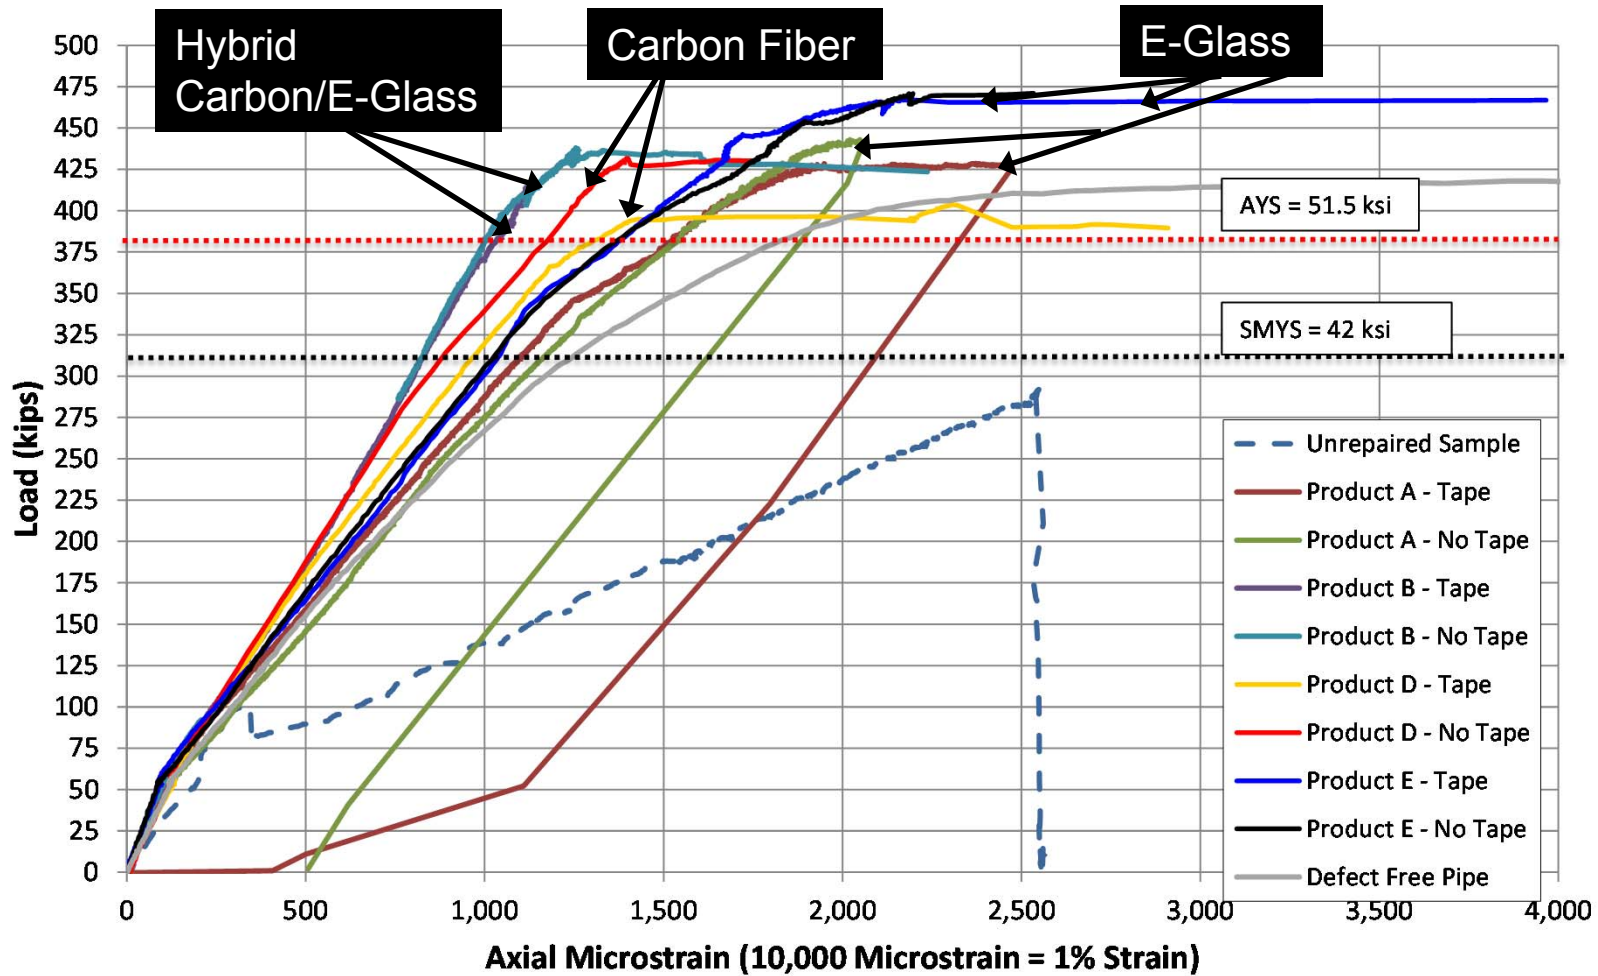
Tension to Failure

Tension vs. Axial Strain for 12.75-inch OD x 0.188-inch , Grade X42 Pipe, With a "Cap Only" Girth Weld With 36% SMYS Internal Pressure

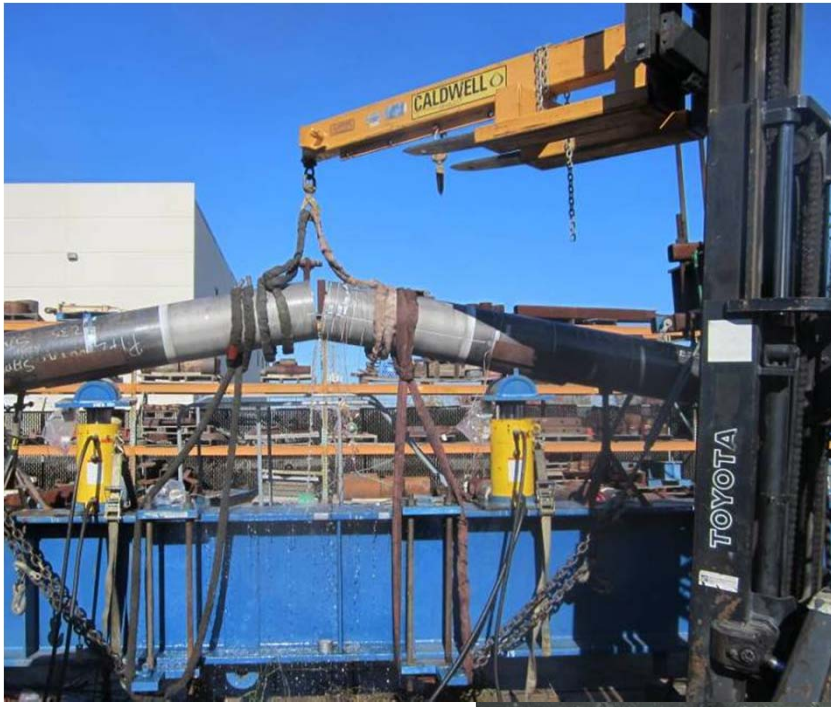
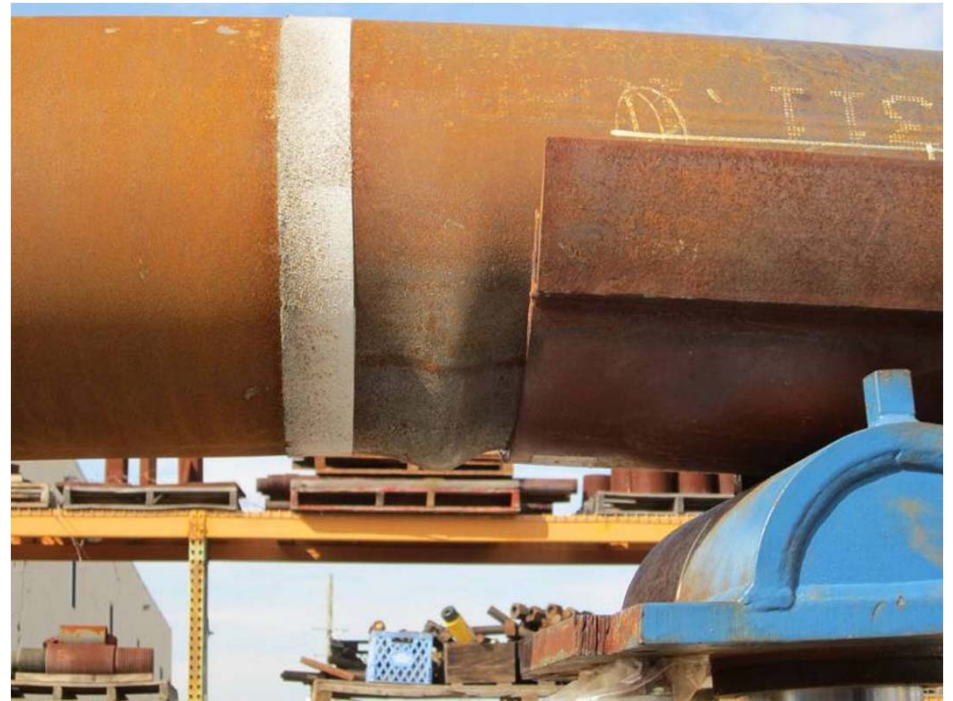
Bending to Failure
