# **INNOVATIVE FRP PILING REPAIR WITHOUT THE USE OF COFFER DAMS**

Steve Bazinet, Larry Cercone, Franz Worth  
Air Logistics Corporation  
Field-Applied Composite Systems Group  
Pasadena, California 91107

## **ABSTRACT**

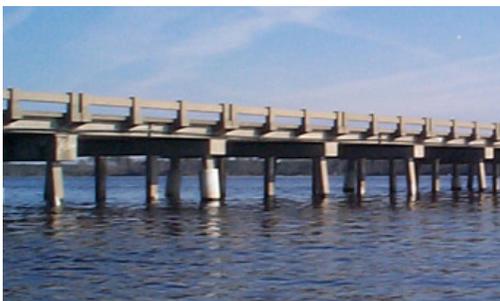
**Figure 1. Bridge over the North River**

The pilings that were repaired support a roadway over the North River in North Carolina. There are over 125 pilings that support this bridge along its entire span. The nominal depth of the river is about 3.6 m. The bridge, located in a tidal zone, has been in service for many years and several of the pilings have suffered severe spalling. This has been caused by freeze/thaw cycles, splash zone water flow, and corrosion of the reinforcing steel. Inspection of the pilings that were to be rehabilitated indicated that the remaining structure had adequate strength and that only a cosmetic repair was required.

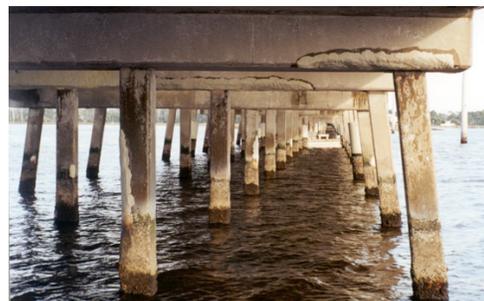
**Figure 2. Concrete deterioration**

Steel reinforced concrete bridge and pier pilings are subject to splash zone damage in both fresh and salt water areas (Figure 2). The damage to the concrete is usually caused by abrasion or impacts by wave and tidal action, collisions with marine vessels, and normal spalling. In addition, oxygen and water penetration can cause corrosion of the reinforcing steel.

When this happens, the resulting expansion causes the concrete to fracture. The corrosion of steel in these structures is exacerbated in the splash zone due to the combination of salt-water and oxygen present in this area of the piling. The damage to the pilings may be cosmetic or structural. In either case, the repair system must restore the piling and reduce further deterioration.

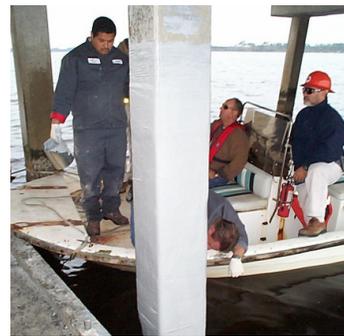
Figure 8. Completed installation

After complete cure, the stretch film was removed and a layer of epoxy adhesive was applied as a protective coating. After completion, the installation was inspected for voids. None were located and the final appearance was excellent (Figure 8).
