# 2011 First Annual Composite Repair Users Group Workshop

Presentation by Chris Alexander

# Overview: Ongoing research and lessons learned

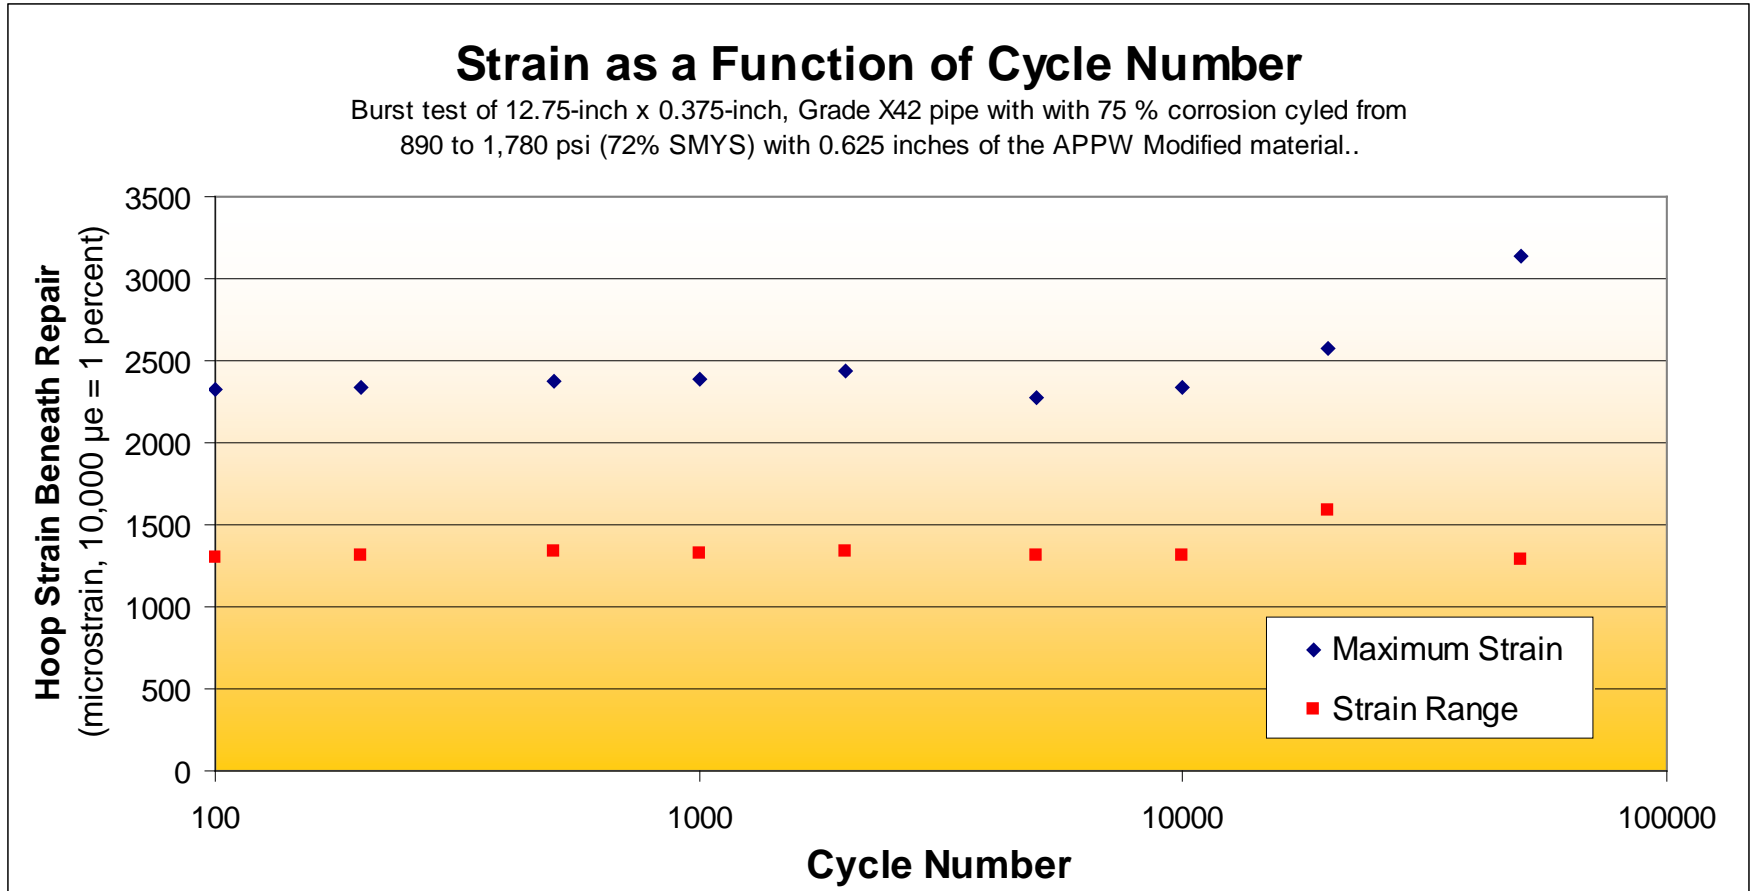
# Pressure Cycle Strain Data (2/2)

Same data presented on previous slides (strain measured beneath repair)

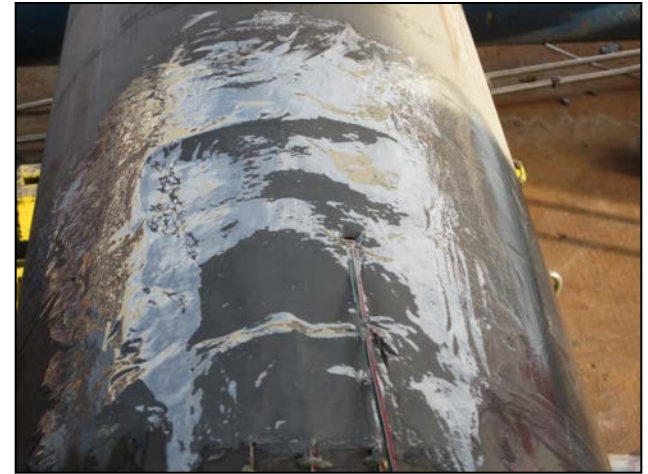
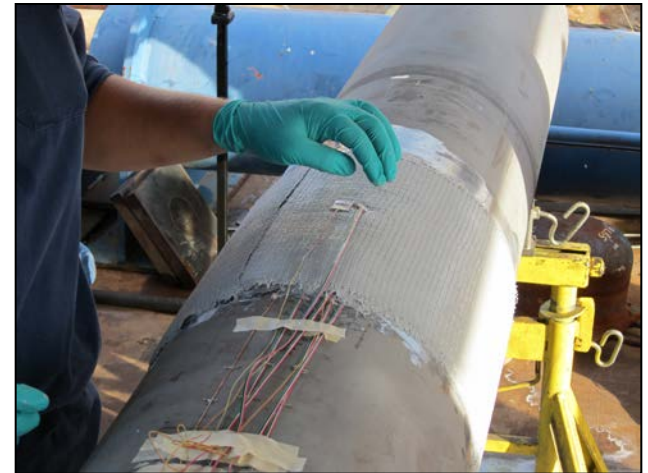
# Inter-lay Strain Study

- During installation strain gages installed between layers
- Strain gages monitored during pressurization
- Ideal means for comparing PCC-2 design stresses to values that actually exist (verification of design theory)

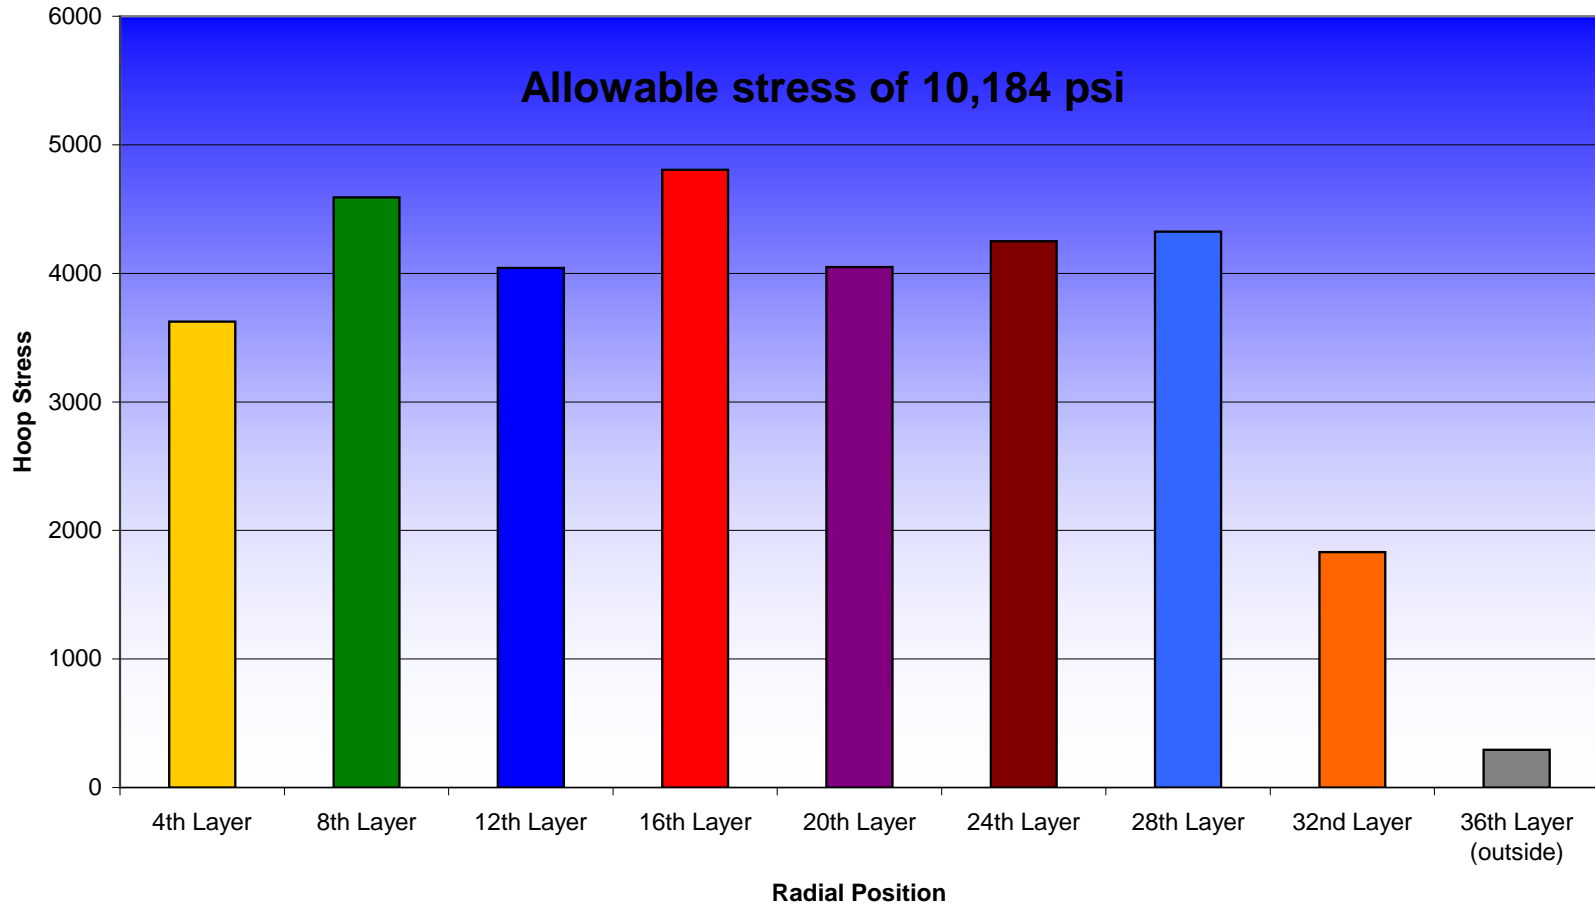
# Inter-Layer Strains (System #1)

## Hoop Strain at 72% SMYS as a Function of Radial Position

The average and maximum stresses measured in the composite material us the 72% SMYS design pressure (1,780 psi) were 3,940 psi and 4,806 psi, respectively.

- Mean tensile stress of 51,700 psi (A)
- Long-term design stress of 20,369 psi (B)
- Allowable stress (0.5 x B) of 10,184 psi (C)
- Maximum measured stress of 4,806 psi (D)
- Maximum measured strain in steel: 2,976  $\mu\epsilon$
- Resulting design margins
  - Allowable stress: 5.1 (A/C)
  - Measured stress: 10.8 (A/D)
  - Usage factor: 0.47 (D/C) – using 47% of the allowable

Data collected at 72% MAOP (design pressure),  $t_{\text{repair}} = 0.76$  inches

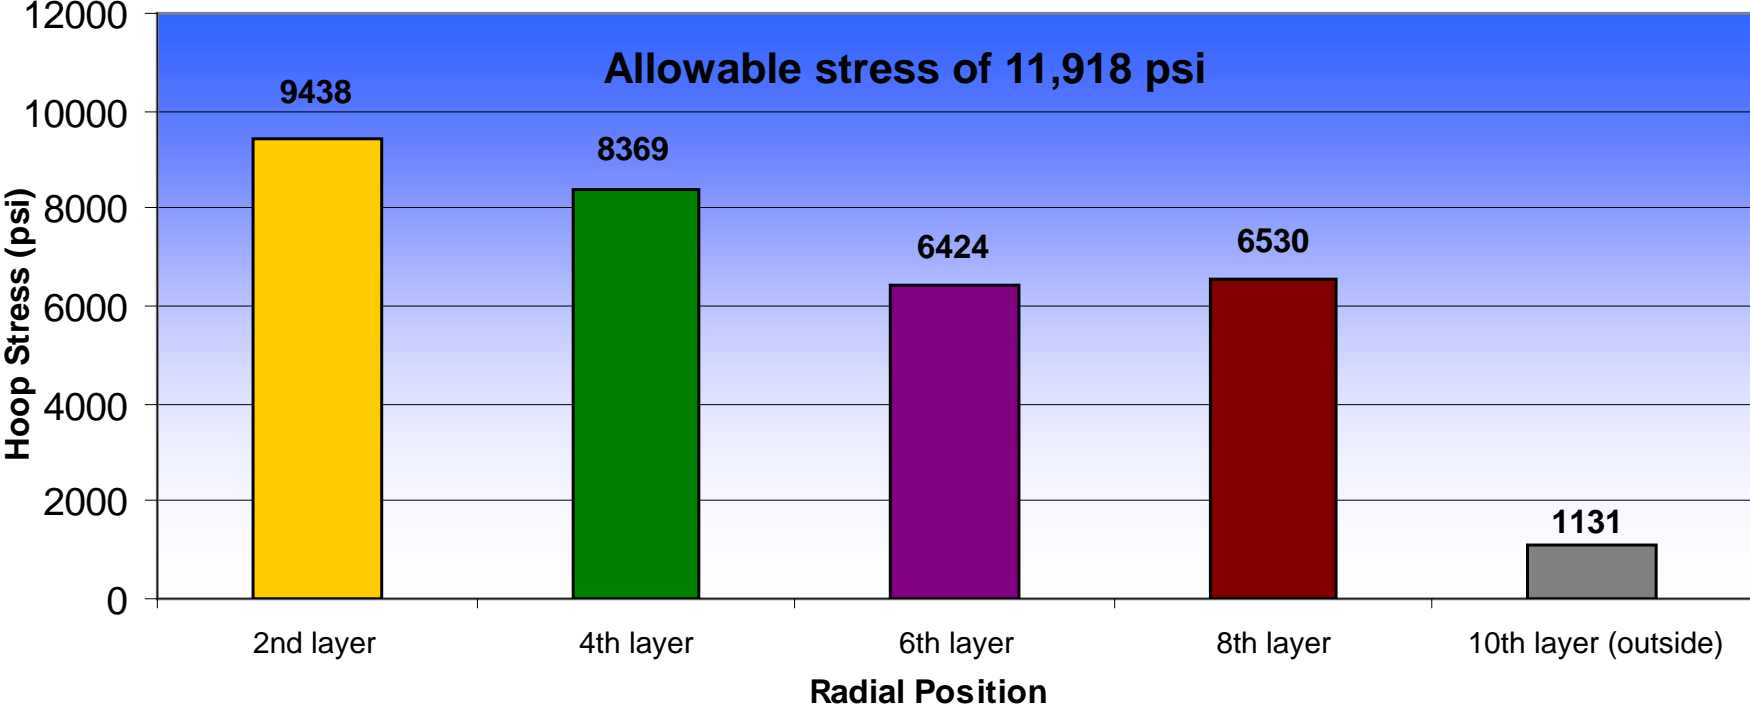
# Inter-Layer Strains (System #2)

Hoop Strain at 72% SMYS as a Function of Radial Position

- Mean tensile stress of 72,088 psi (A)
- Long-term design stress of 23,836 psi (B)
- Allowable stress (0.5 x B) of 11,918 psi (C)
- Maximum measured stress of 9,438 psi (D)
- Maximum measured strain in steel: 3,125  $\mu\epsilon$
- Resulting design margins
  - Allowable stress: 6.0 (A/C)
  - Measured stress: 7.6 (A/D)
  - Usage factor: 0.79 (D/C) – using 79% of the allowable

Data collected at 72% MAOP (design pressure),  $t_{\text{repair}} = 0.63$  inches
