## EVALUATING THE EFFECTS OF WRINKLE BENDS ON PIPELINE INTEGRITY

**Chris Alexander**  
Stress Engineering Services, Inc.  
Houston, Texas  
[chris.alexander@stress.com](mailto:chris.alexander@stress.com)

**Satish Kulkarni**  
El Paso Pipeline Group  
Houston, Texas  
[satish.kulkarni@elpaso.com](mailto:satish.kulkarni@elpaso.com)

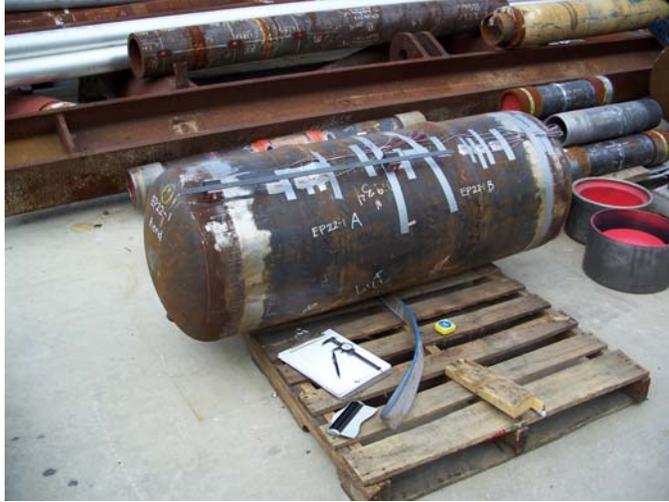
- Steel straight edge with graduated markings (1 inch minimum spacing)
- Magnetic bases for offsetting the steel straight edge
- Dial calipers
- Steel profile comb

Figure 1 – Tools used to measure wrinkle profile

From the welded test samples, wrinkle profile measurements were made. **Figures 1 and 2** are photographs showing the equipment that was used, which included:

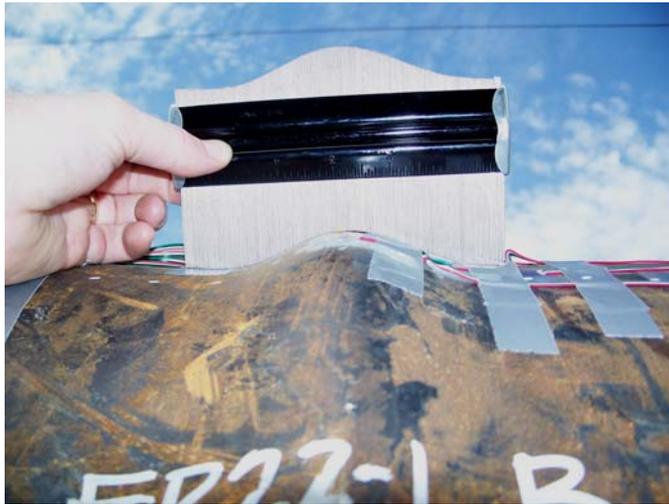
In addition to measuring the wrinkle profiles, a useful tool is the steel profile comb. A photograph showing the use of this comb on Sample EP22-1B is shown in **Figure 2**. Using this tool provides a quick check on the  $h/L$  ratio as the profile can be traced onto a sheet of paper thus permitting  $h$  and  $L$  to be measured. **Figure 3** shows the geometry associated with the length,  $L$ , and height,  $h$ , values. The length,  $L$ , is represented as the distance over which the curvature of the wrinkle decays back to the original profile of the pipe. For the pipes used in this study, the length was relatively well defined as the pipe

Figure 2 – Measurement made using steel profile comb

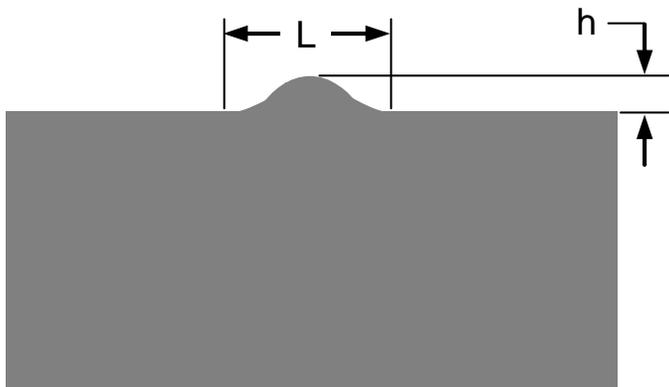
Figure 3 – Geometry measurement parameters for the wrinkle profile

As discussed prior studies, the wrinkle severity ratio,  $h/L$ , is the geometric characteristic that best describes the severity of a given wrinkle. Any integrity management program charged with assessing wrinkles (and dents for that matter) should consider the  $h/L$  ratio as the first-line grading tool. This ratio is simple to acquire in the field from an exposed pipeline.

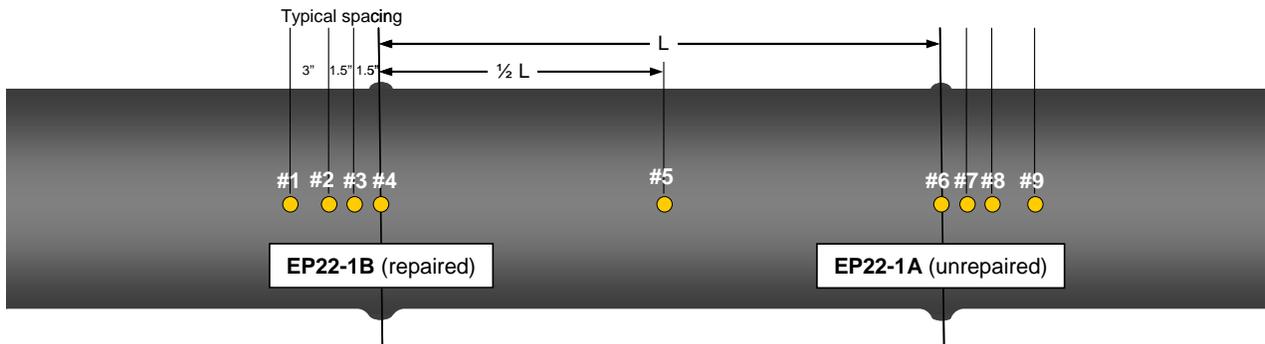
**Figure 4** provides a schematic showing where strain gages were installed on each wrinkle. As noted, there are two wrinkles on each test sample and a middle gage at location #5 was installed on the bare pipe between the wrinkles to capture nominal hoop and axial strain values. As noted in this figure, a total of nine strain gages were installed on each test sample. For the pressure cycle testing, data were recorded at 1 scan per second. After testing the results were output to an EXCEL spreadsheet for post-processing. Results are presented in a later section of this paper.

**Figure 4 – Schematic showing strain gage locations**  
(markings specifically for Sample EP22-1)

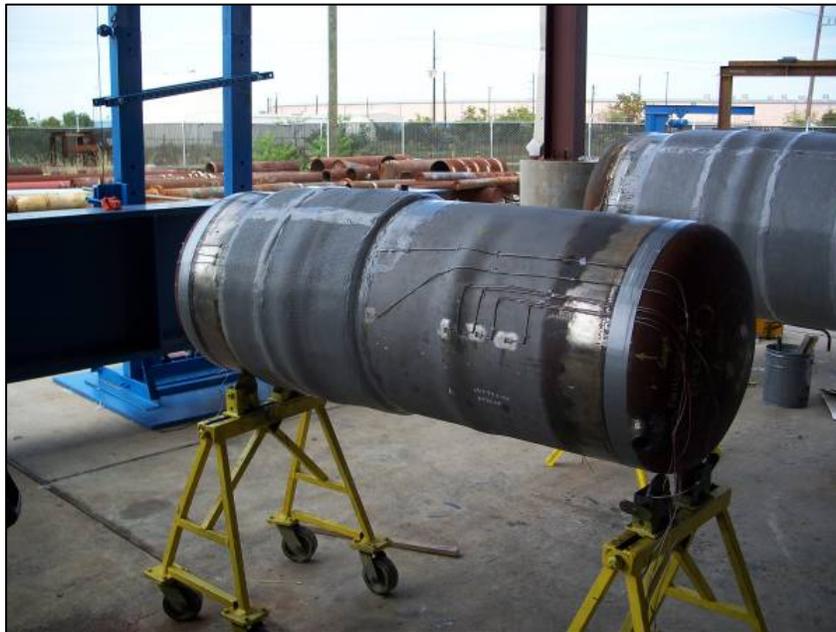
Strain gages were installed prior to installation of the APPW material. Epoxy putty was used to create a smooth profile around the strain gage lead wires. Additionally, a layer of epoxy was painted to seal the exposed pipe prior to installation of the reinforcing material. **Figure 5** shows a completed repair on the pipe sample using the composite reinforcement.

**Figure 5 – Photo showing completed installation of Armor Plate® Pipe Wrap**

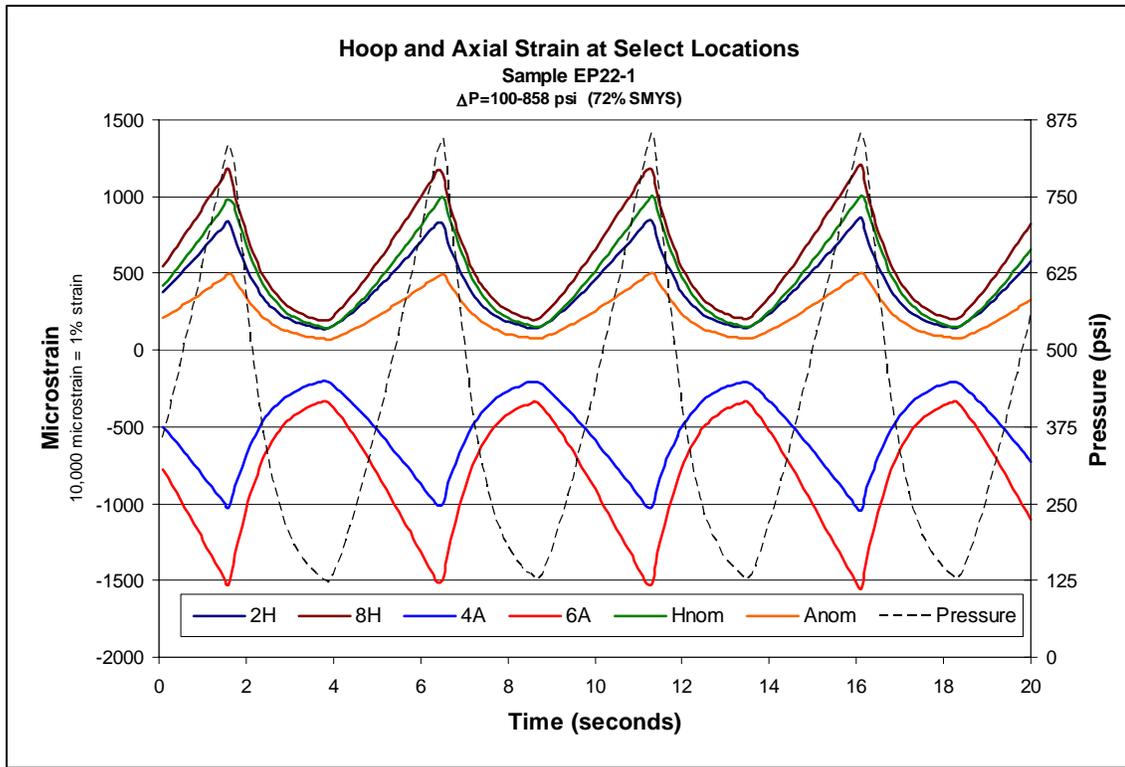
**Strain Gage Results** A significant body of strain data was collected; however, the focus in this presentation is the maximum strain range that occurred in each of the samples. **Figure 6** provides hoop and axial strain gage results for sample EP22-1. Also included in this plot are the nominal hoop and axial strains calculated using the following relations. Note that these units of strain (and all strain gage data presented herein) are in microstrain,  $\mu\epsilon$ , where 10,000  $\mu\epsilon$  equals 1 percent strain. To convert strain to stress, simply multiply strain (measured in units of microstrain) by 30 (units are in psi).

**Figure 6 – Alternating hoop and axial strain gage results for Sample EP22-1**  
 (Gages 1 - 4 REPAIRED and Gages 5 - 9 UNREPAIRED)

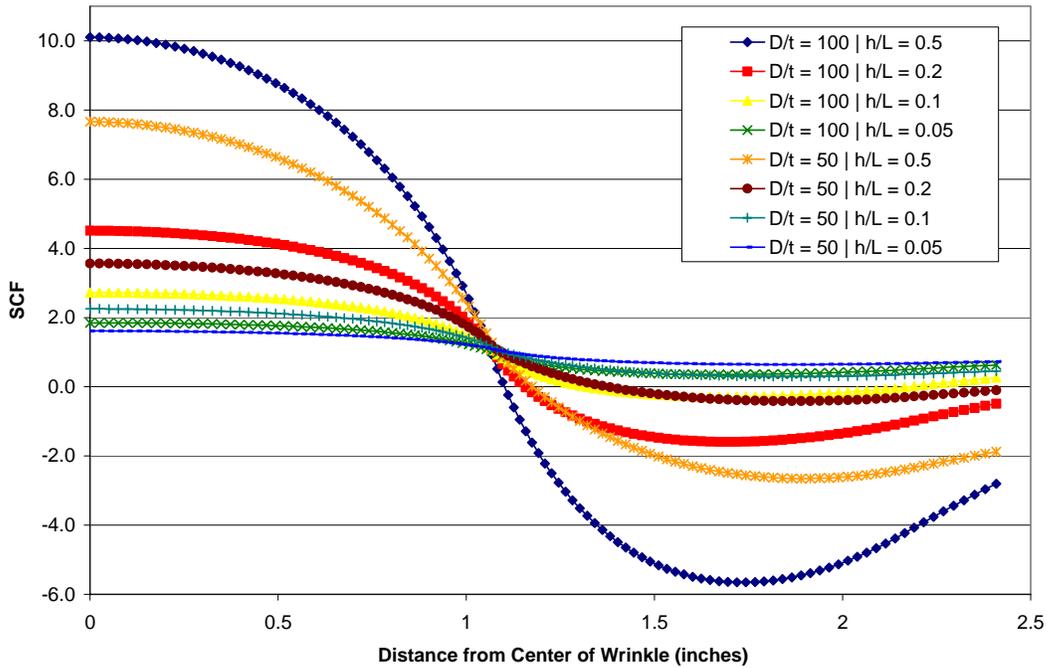
**Figure 7** plots the axial SCFs on the inside surface of the pipe for the range of pipe D/t and h/L ratios considered in this study. As expected, the maximum SCF is associated with the larger D/t pipe and the wrinkle severity ratio, h/L, significantly impacts the magnitude of the SCF. These SCFs serve as the foundation for further discussions on how the wrinkle bend severity impacts integrity management.

**Figure 7 – Axial SCFs on inside pipe surface as a function of axial position**  
 (the length,  $L$ , of the wrinkles maintained at 6.0 inches while the height,  $h$ , was varied which means that for the above plots the wrinkle half-length is 3.0 inches)

- The maximum axial stresses occur in the center of the wrinkle and decay relatively rapidly in moving into the nominal straight section of pipe. These results are consistent with fatigue cracks initiated experimentally.
- The maximum axial tensile stress occurred on the inside surface of the pipe. This is also consistent with experimental findings showing that fatigue cracks initiate from the inside surface of the wrinkle.
- Recognizing that in a capped end sample, axial stresses are one-half hoop stress, it is clear that the axial SCFs are larger than the hoop SCFs (even with a relatively shallow wrinkle severity ratio of 0.05). In reviewing the legends associated with each of the plots, the maximum axial stress on the inside surface of the wrinkle is 43.4 ksi, while the maximum hoop stress is 50.4 ksi.

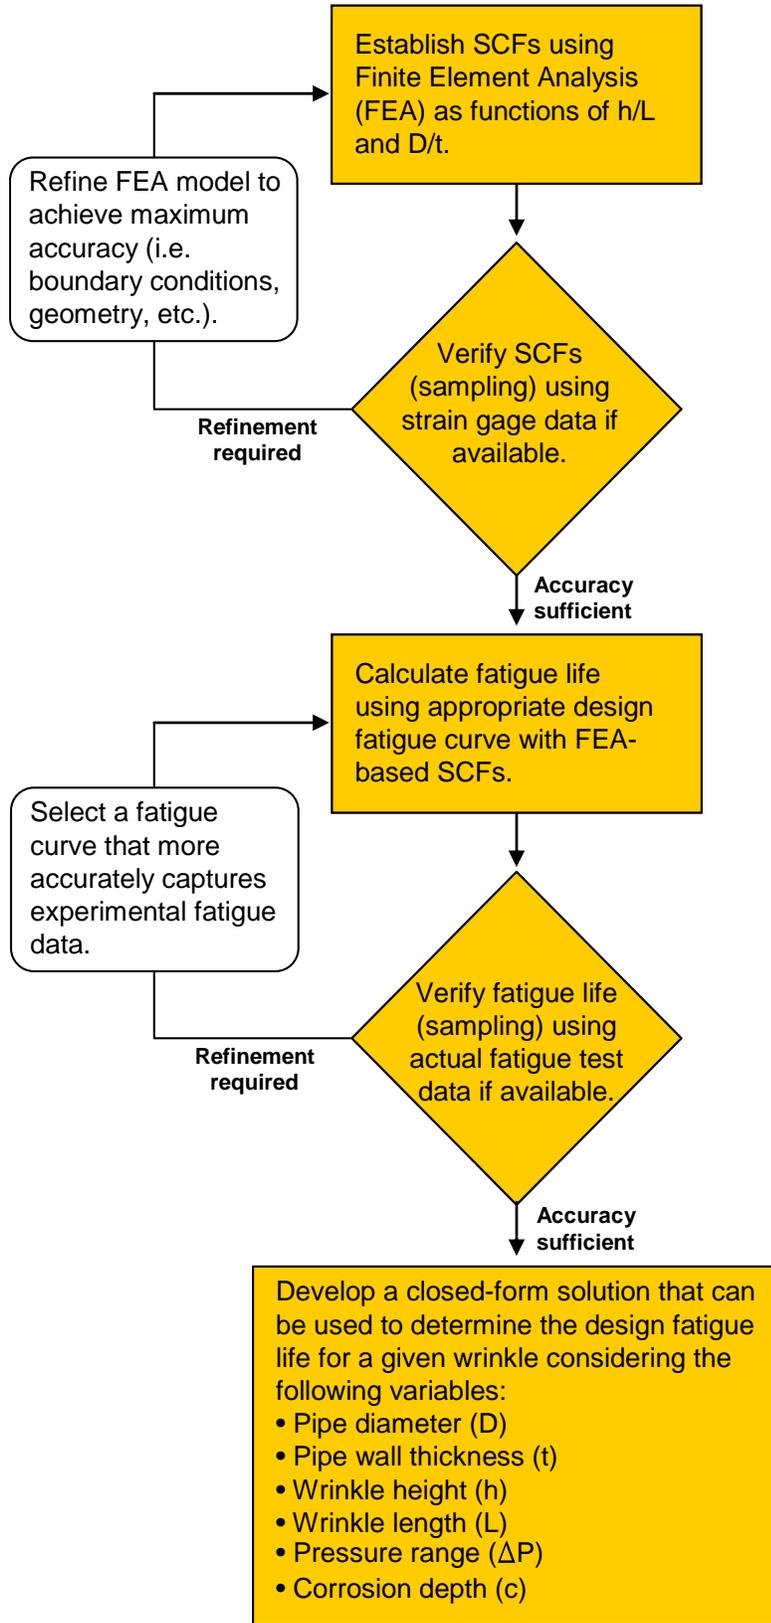
**Figure 8** is a flow chart that shows the process developed to formulate an expression for estimating a design fatigue life. The discussions that follow provide specific details on how this process was completed.

Figure 8 – Wrinkle assessment flow chart

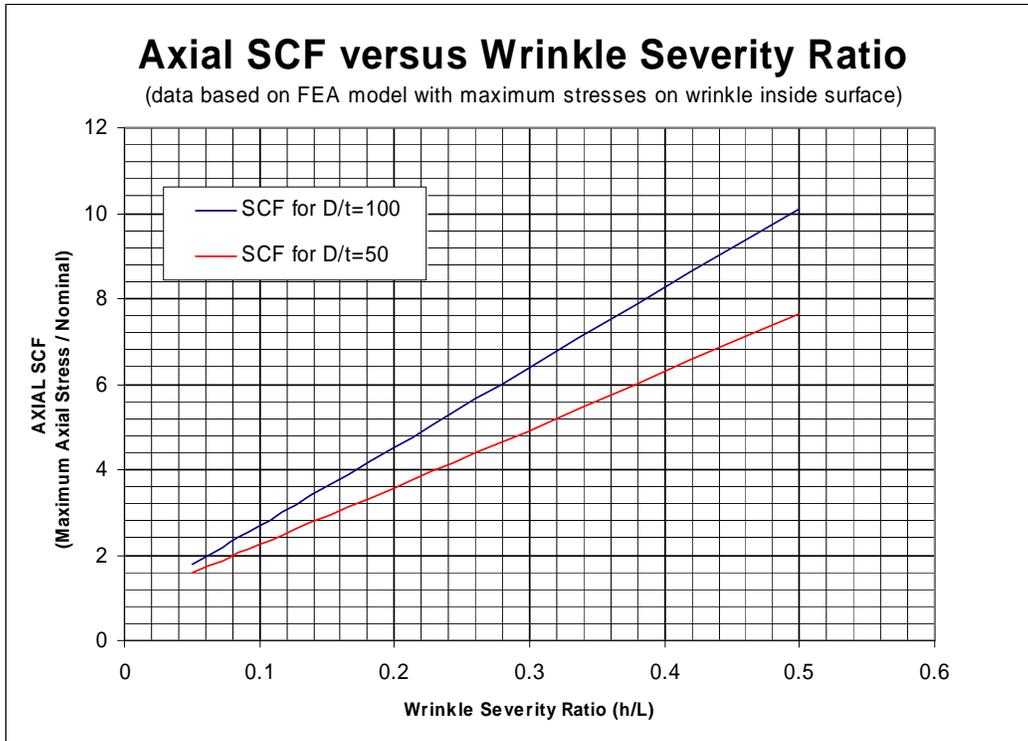
From the outset the focus in using finite element analysis was to determine the effects of the wrinkle profile ratio  $h/L$ , and pipe diameter to wall thickness ratio,  $D/t$ . Shown in **Figure 9** are axial SCFs calculated as functions of  $D/t$  and  $h/L$ .

Figure 9 – Axial SCFs as functions of D/t and h/L

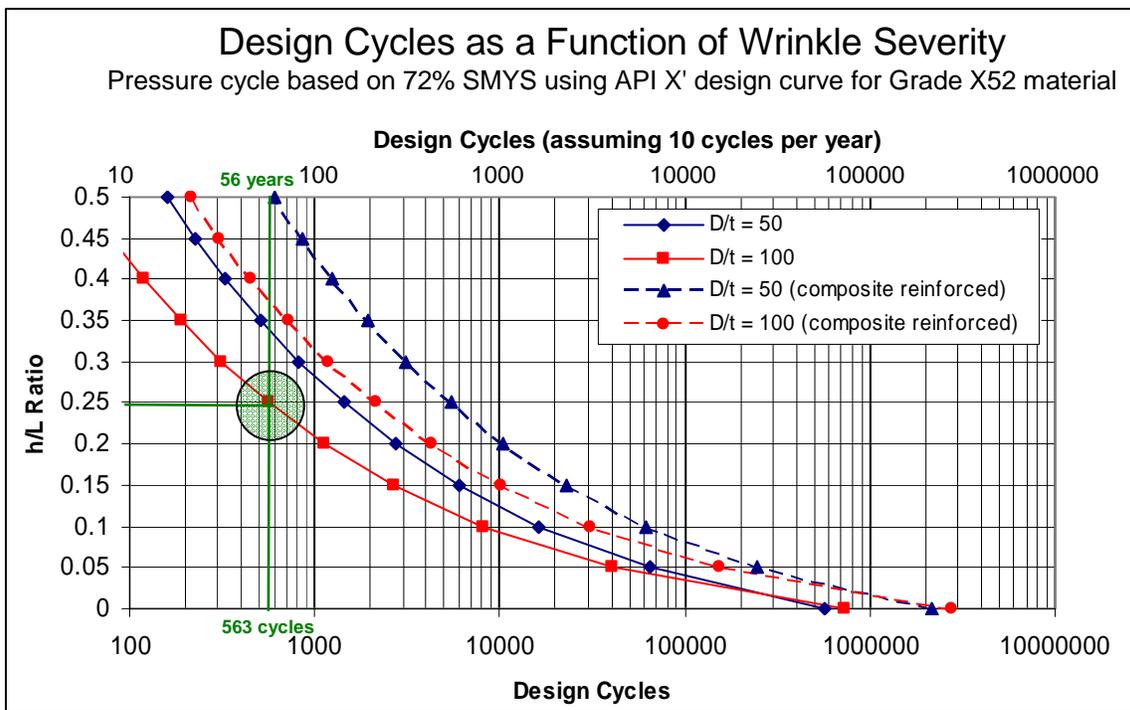
Using the methodology developed previously that generated the single closed-form solution relating design cycle life as a function of pressure state, wrinkle geometry, and pipe  $D/t$  ratio, a nomograph was developed as shown in **Figure 10**. This figure relates the  $h/L$  ratio to design life and years of service. An example data set is shown considering an  $h/L$  ratio of 0.25 (a relatively severe wrinkle) in a pipe having a  $D/t$  ratio of 100. As noted in the chart, the corresponding number of design cycles is 563, which then corresponds to 56 years of service assuming 10 cycles per year.

Figure 10 – Nomograph relating h/L ratio to design life and years of service  
(analysis data plotted includes results with and without composite reinforcement)
