DEVELOPMENT OF A CARBON-FIBER COMPOSITE REPAIR SYSTEM FOR OFFSHORE RISERS

Chris Alexander

Stress Engineering Services, Inc.
Houston, Texas

ABSTRACT

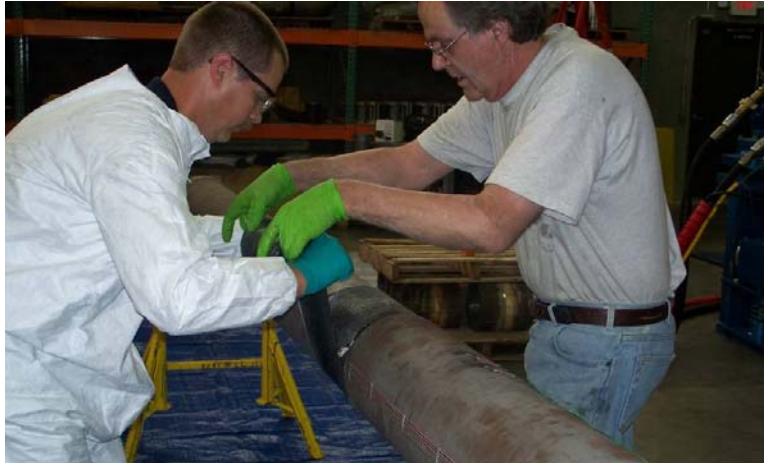
Figure 7 – Installing the hoop wrapped inner carbon layers

1. Sandblast the surface of the pipe where the composite repair to be installed.
2. To repair the 24 inch long corroded section of pipe, the uniaxial stitched carbon cloth material was cut to length. Repairs were made by saturating the cloth with two part epoxy and wrapping the cloth around the pipe in the hoop direction. Two rows of material, each totaling 10 layers, were installed in the damaged region as shown in **Figures 7** to produce a total thickness of 0.200 inches.

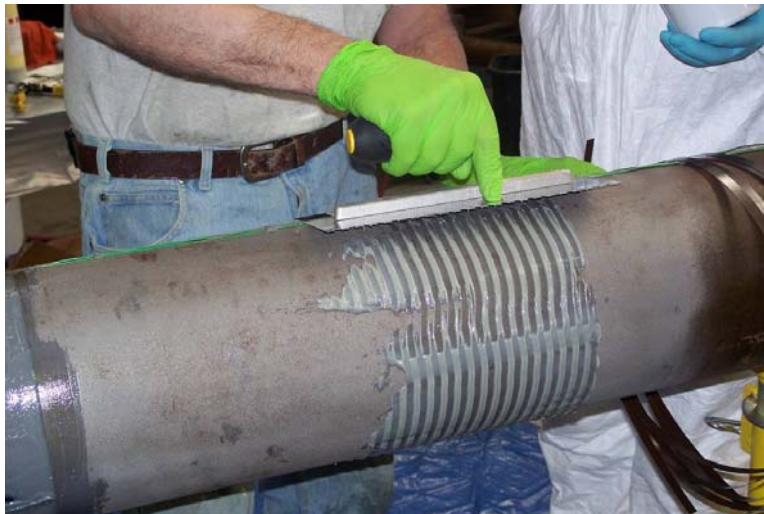
Figure 8 – Applying the epoxy adhesive using a slotted hand trowel

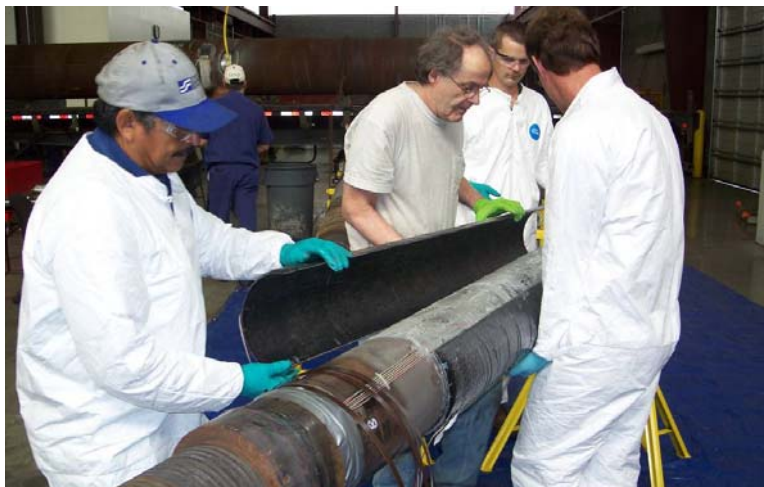
Figure 9 – Installation of the carbon half shells

5. The carbon half shells were installed on the outside surface of the pipe. The 60-inch long half shells were centered axially on the corroded region. **Figure 9** shows the carbon half shells being installed on the 8-ft long tension sample.

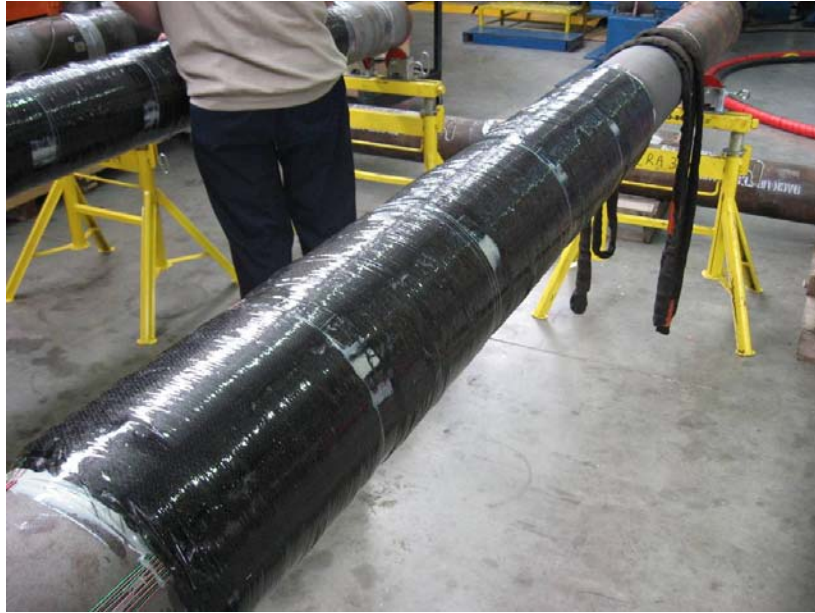
Figure 10 – Final view of cured repair prior to testing

7. Once the carbon half shells were locked in place with the steel banding clamps, the outer hoop wrapped carbon material was installed. The same materials used previously for the inner corrosion hoop layers were used in this layer (uniaxial stitched carbon with an epoxy matrix); however, only 5 layers were installed resulting in a total thickness of 0.100 inches. Five rows of carbon material were installed that resulted in a small axial 1.5 inch gap between each of the layers. Stricker wrap material was installed on the outside surface of the hoop wraps.
8. The samples were permitted to cure overnight and the stricker wrap was removed the following morning. **Figure 10** shows the final repair including the carbon half shells and outer carbon hoop wrapped material.
