REPAIR OF PIPELINES HAVING MECHANICAL DAMAGE AND PLAIN DENTS USING COMPOSITE MATERIALS

Dr. Chris Alexander
Stress Engineering Services, Inc.

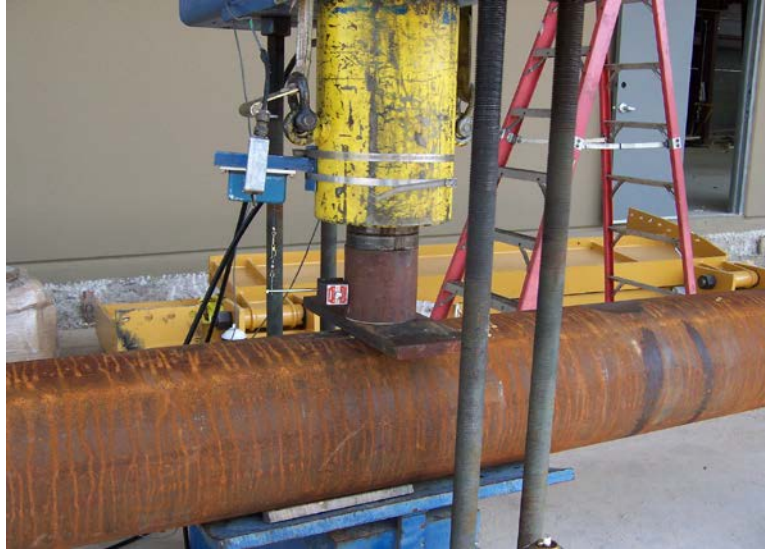
Figure 1 - Dent installation rig to install dents

3. Install dents in the pipe using a 6-inch wide plate. The initial indentation depth was 15 percent of the pipe's outer diameter and the indenter plate. Four dents were installed in each 20-ft long pipe sample. Each dent was offset 2 inches longitudinally from the respective gouge, resulting in a total defect length of 8 inches. **Figure 1** shows the dent installation rig.
4. Allow each dent to reround elastically with removal of the indenter and measure the longitudinal profile (side view of dent and process shown in **Figure 2**).
5. Apply internal pressure equal to 50 percent of the maximum operating pressure (36 percent of SMYS) and hold for 5 minutes. Return the internal pressure to 0 psi and measure the profile.

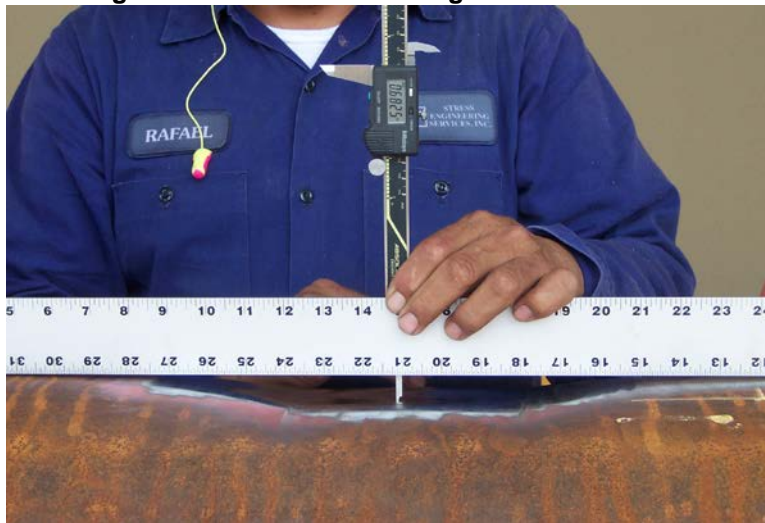
Figure 2 - Measuring dent depth and profile

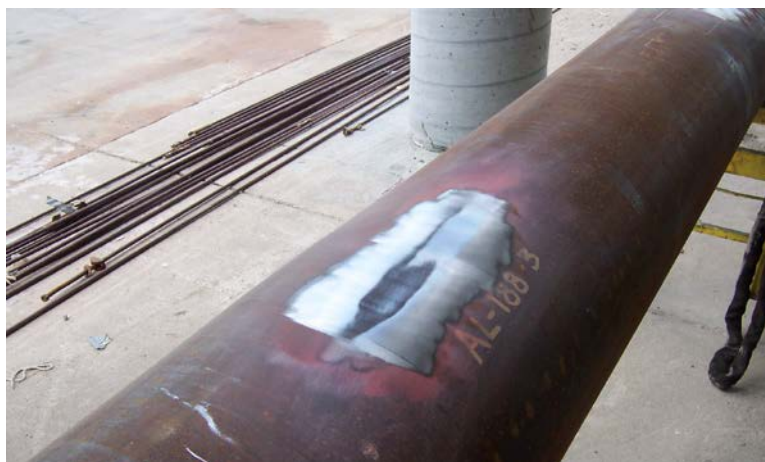
Figure 3 - Gouge removal by grinding

1. Remove the gouge by grinding with a hand-held grinder. Dye penetrant was used to ensure that the crack was completely removed. Measure the remaining wall thickness. **Figure 3** shows one of the samples polished in its final state before installation of the repair material.

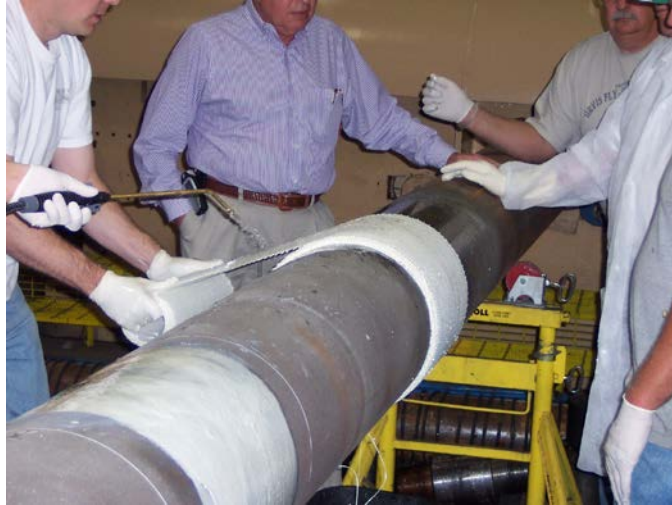
Figure 4 – Installing composite material on pipe

Figure 4 and **Figure 5** are photographs taken during the installation of the Aquawrap composite repair on the damaged sections of the test pipes. This system uses an E-glass material pre-impregnated with a water-activated urethane resin system.

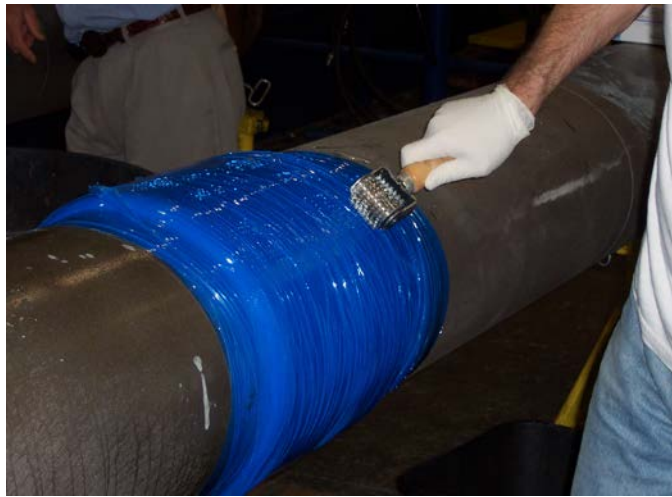
Figure 5 - Perforating plastic wrap to permit off-gassing during cure

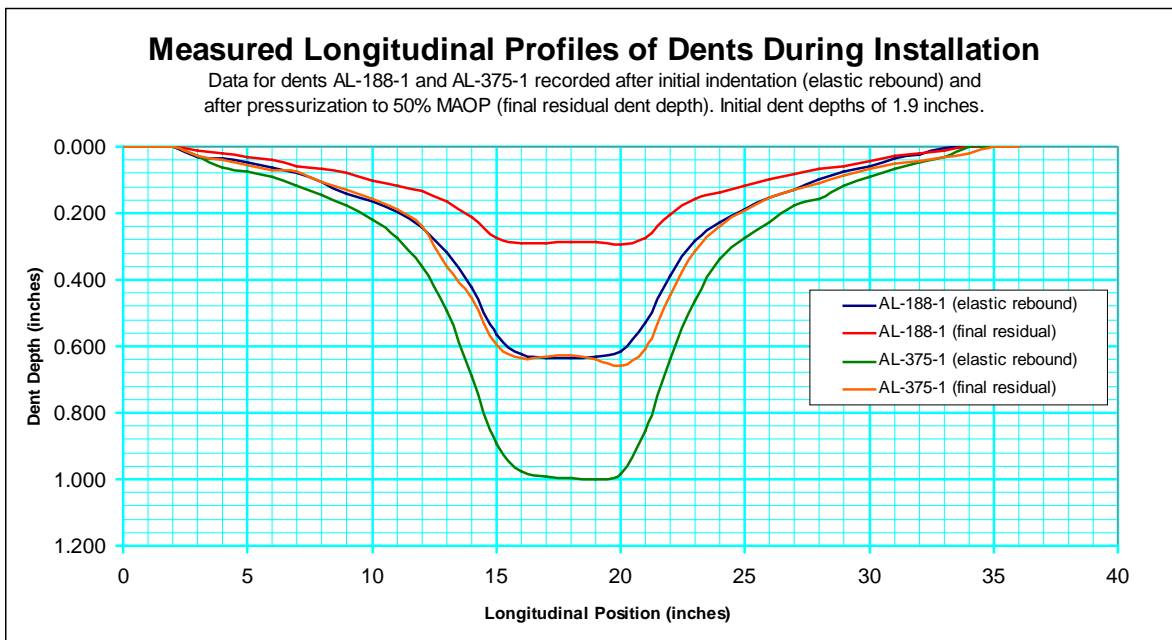
Figure 6 - Longitudinal profile measurements of exemplar dents

Figure 6 shows the longitudinal profile measurements for test samples AL-188-1 and AL-375-1 (the 188 and 375 numbers correspond to the 0.188-inch and 0.375-inch nominal wall thicknesses, respectively). The measurements correspond to readings taken after initial indentation that capture the elastic rebound and measurements taken after pressurization to 50 percent MAOP. As with the data presented in **Table 1**, it is clear that a significant portion of the dent is removed by the application of internal pressure.

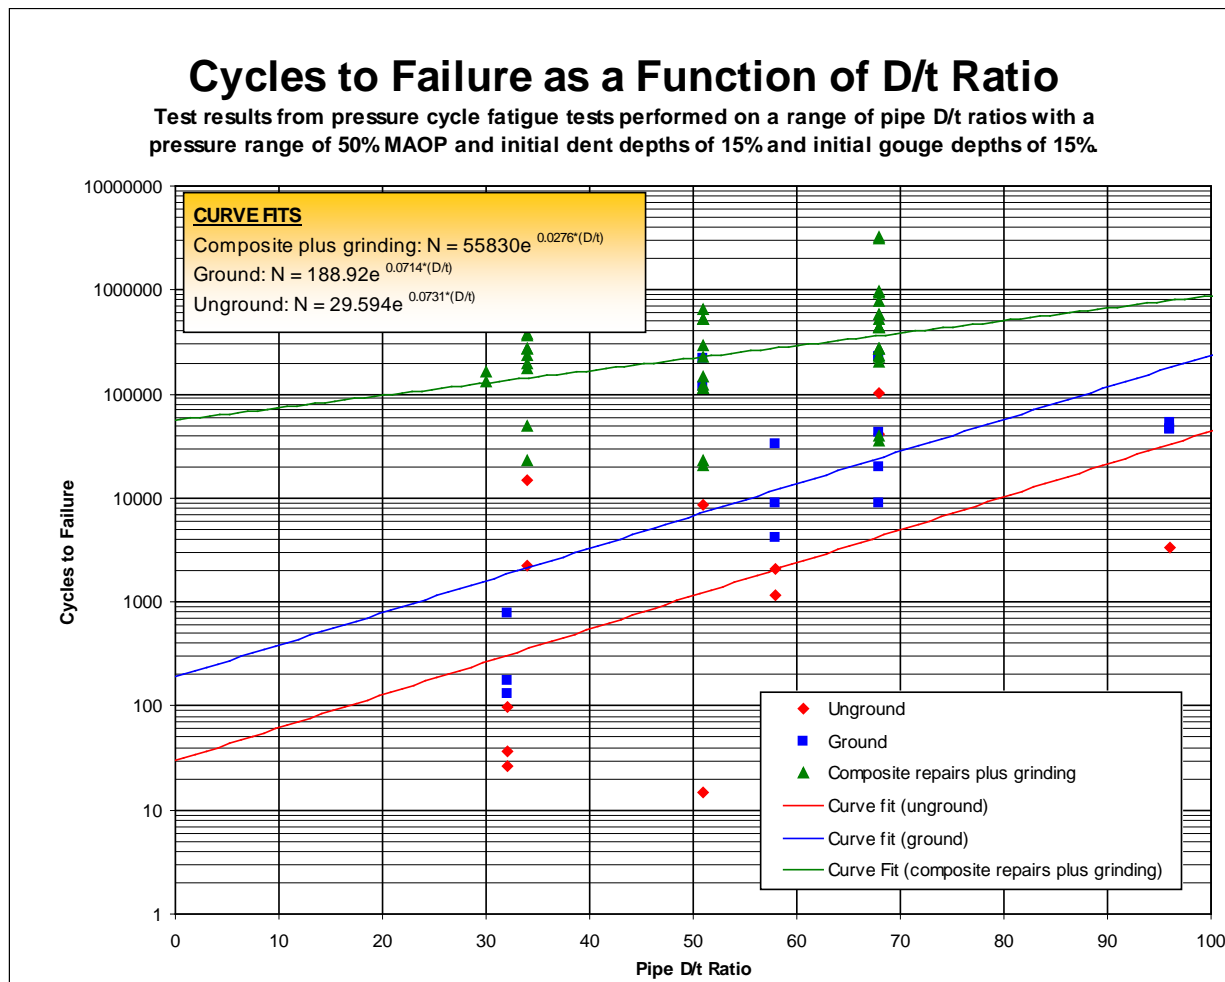
Figure 7 – Fatigue data for repaired and unrepaired mechanically-damaged pipes

Figure 7 plots all data acquired to date on mechanically-damaged pipes repaired using composite materials. Also included in this plot are curve fits (and their corresponding algebraic equations) for each of the following data sets:

- Unrepaired mechanical damage including dents with gouges
- Mechanical damage repaired by grinding ONLY
- Mechanical damage repaired by grinding and composite materials

As noted in **Figure 7**, there is some inherent scatter in the above data sets. This is typical for fatigue data. Initially, there might be some concern over the scatter in the composite repair fatigue data; however, what should be noted is that there is a significantly smaller level of scatter associated with the results for each individual composite repair system. As a point of reference consider the following data sets for two different composite repair systems.
