ENDURANCE TESTING OF COMPOSITE REINFORCED WELDED ALUMINUM STRUCTURES

Larry Cercone and Franz Worth
Air Logistics Corporation, Pasadena, CA 91107

ABSTRACT

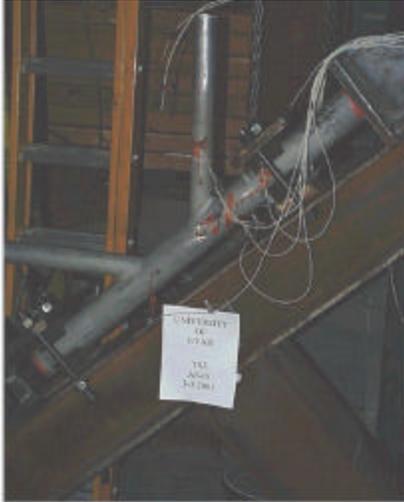
Figure 10. Illustration of test setup and strain gauge placement.

Following is an illustration of how the test specimen appears when attached to the test apparatus (Figure 10). Note the placement of the strain gauges that are placed near the suspected failure area. A typical failure mode of the test specimen is also shown (Figure 11).

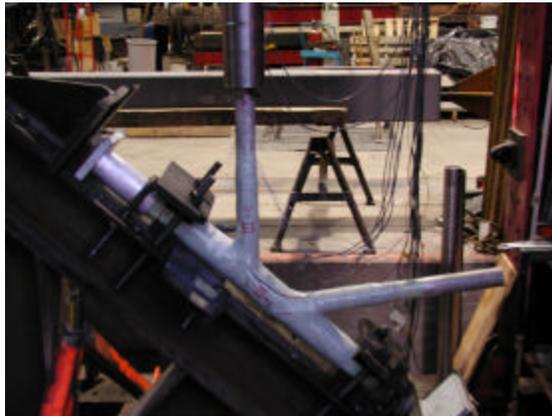
Figure 12. Fatigue test in progress.

Series III are the test results for the fatigue test of cracked aluminum connections repaired using Air Logistics Corporation’s FRP repair system (Figures 12 & 13).

Specimen	Failure	Maximum Load	R	Number of Cycles
III-a	Weld, Base, & FRP	21 kips	0.190	6,763
III-b	Weld, Base, & FRP	15 kips	0.267	69,194
III-c	Weld, Base, & FRP	10 kips	0.200	1,000,000 Static 21 kips
