EVALUATING DAMAGED SUBSEA PIPELINES USING AN ENGINEERING-BASED INTEGRITY MANAGEMENT PROGRAM

Chris Alexander
Stress Engineering Services, Inc.
Houston, Texas
chris.alexander@stress.com

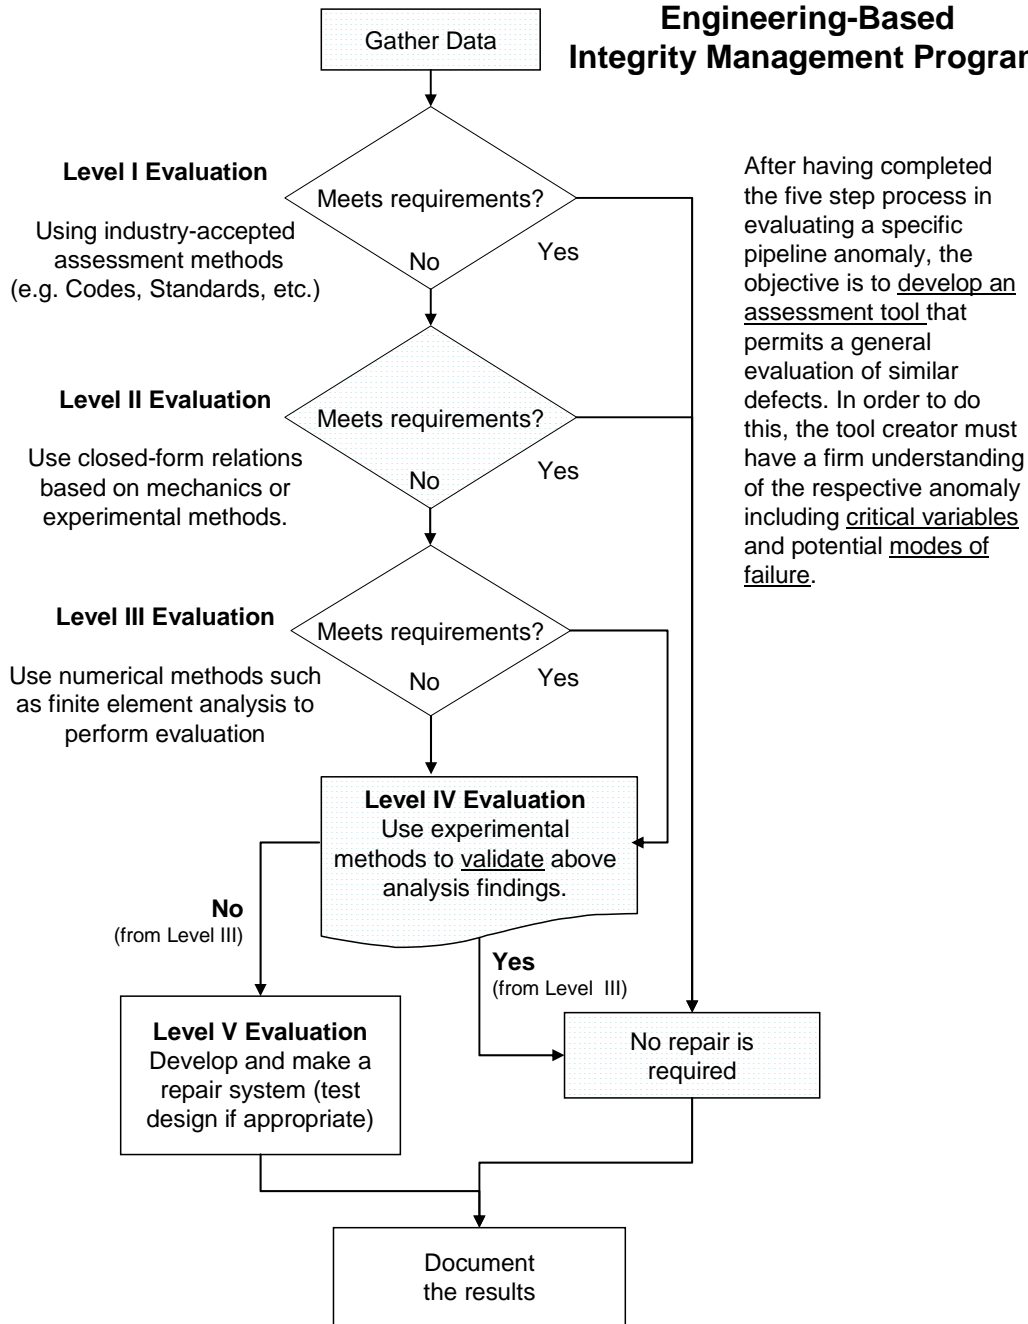
Figure 1 – Flow chart showing the Five Step Engineering-Based Integrity Management Program

This paper describes a five step process for evaluating pipeline imperfections based on the EB-IMP. Figure 1 is a flow chart of the proposed process that builds on the basics of API 579. This paper includes details on how pipeline companies can use the EB-IMP to evaluate the integrity of a selected anomaly using a methodology that integrates analysis and testing methods, as well as using prior experience and regulations set forth in the appropriate codes and standards.

Referring once again to Figure 1, the reader is encouraged to review the five steps involved in the assessment process. A body of text is included in this figure that reads:

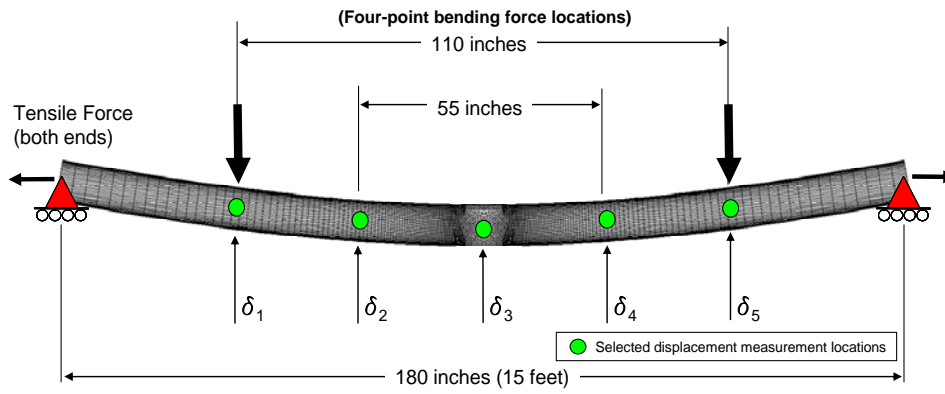
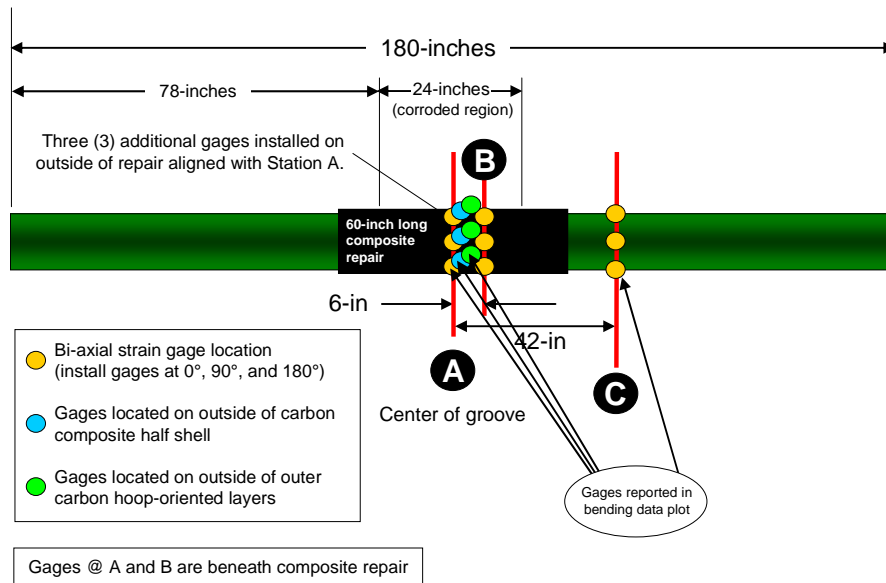
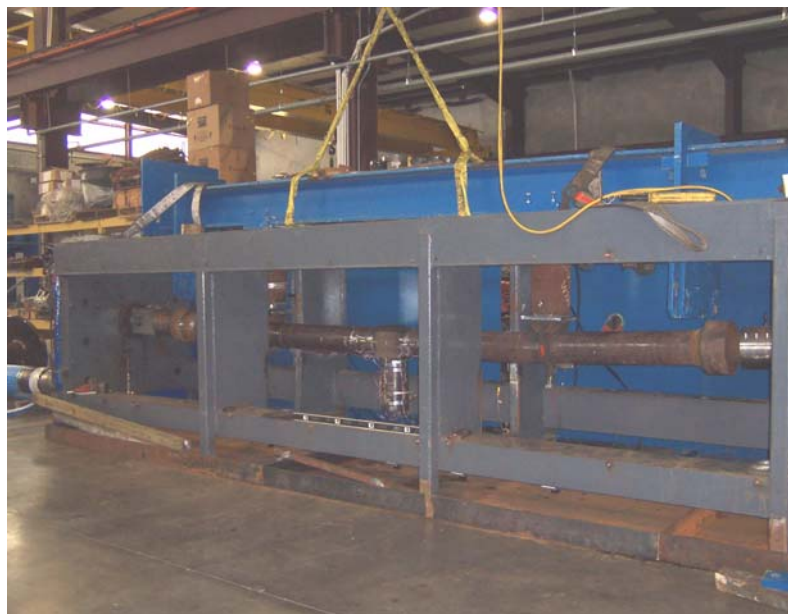
Figure 2 – Images of pressure-tension-bending load frame test set-up

Studies have been conducted for pipeline operators, manufacturers, and regulators to determine the level of reinforcement provided to damaged pipelines and risers using composite materials. One of the benefits in studying composite reinforcement numerically is the ability to optimize the composite repair for a given set of loading conditions. As a point of reference, Figure 2 and Figure 3 provide several photographs and images from a study that developed an optimized composite repair system for reinforcing corrosion in shallow water pipelines and risers subject to internal pressure, tension, and bending loads. Included in this figure is a plot showing how strain was reduced in the full-scale test sample with the presence of the

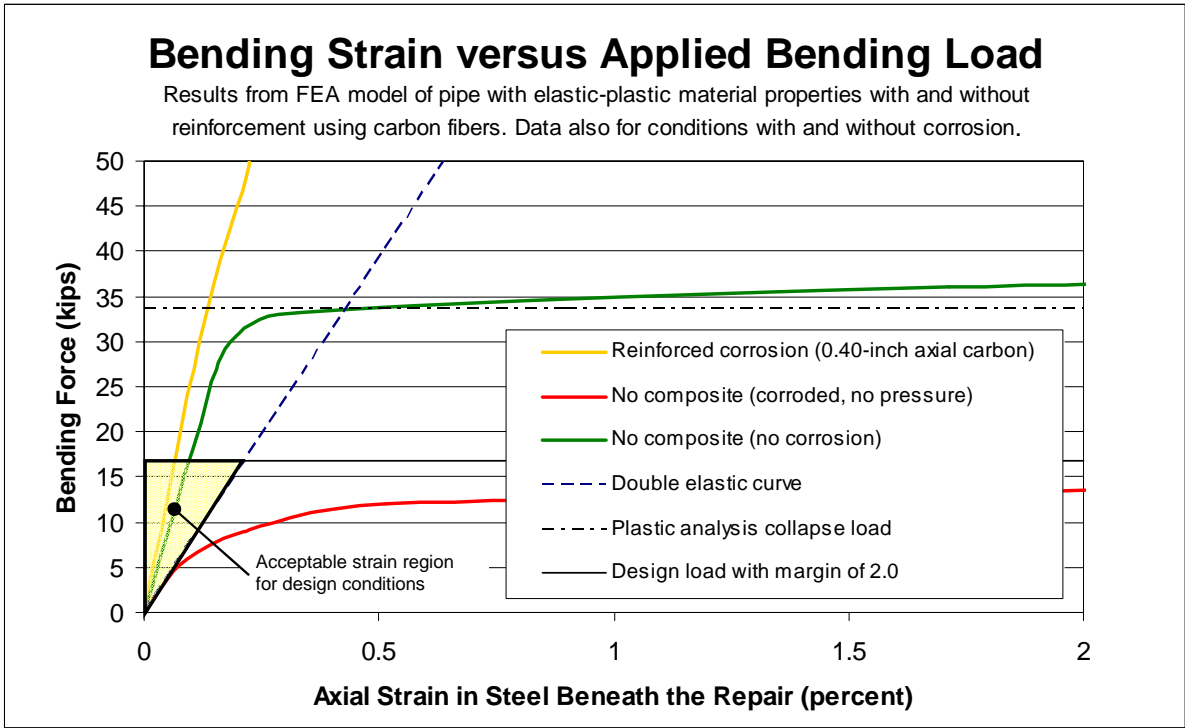
Figure 3 – Bending force versus axial strain in pipe
 (carbon repair with 0.200-inch thick hoop | 0.400-inch axial | 0.100-inch layers)

composite material. The composite repair of the corroded region was found to be stronger than the base pipe material.

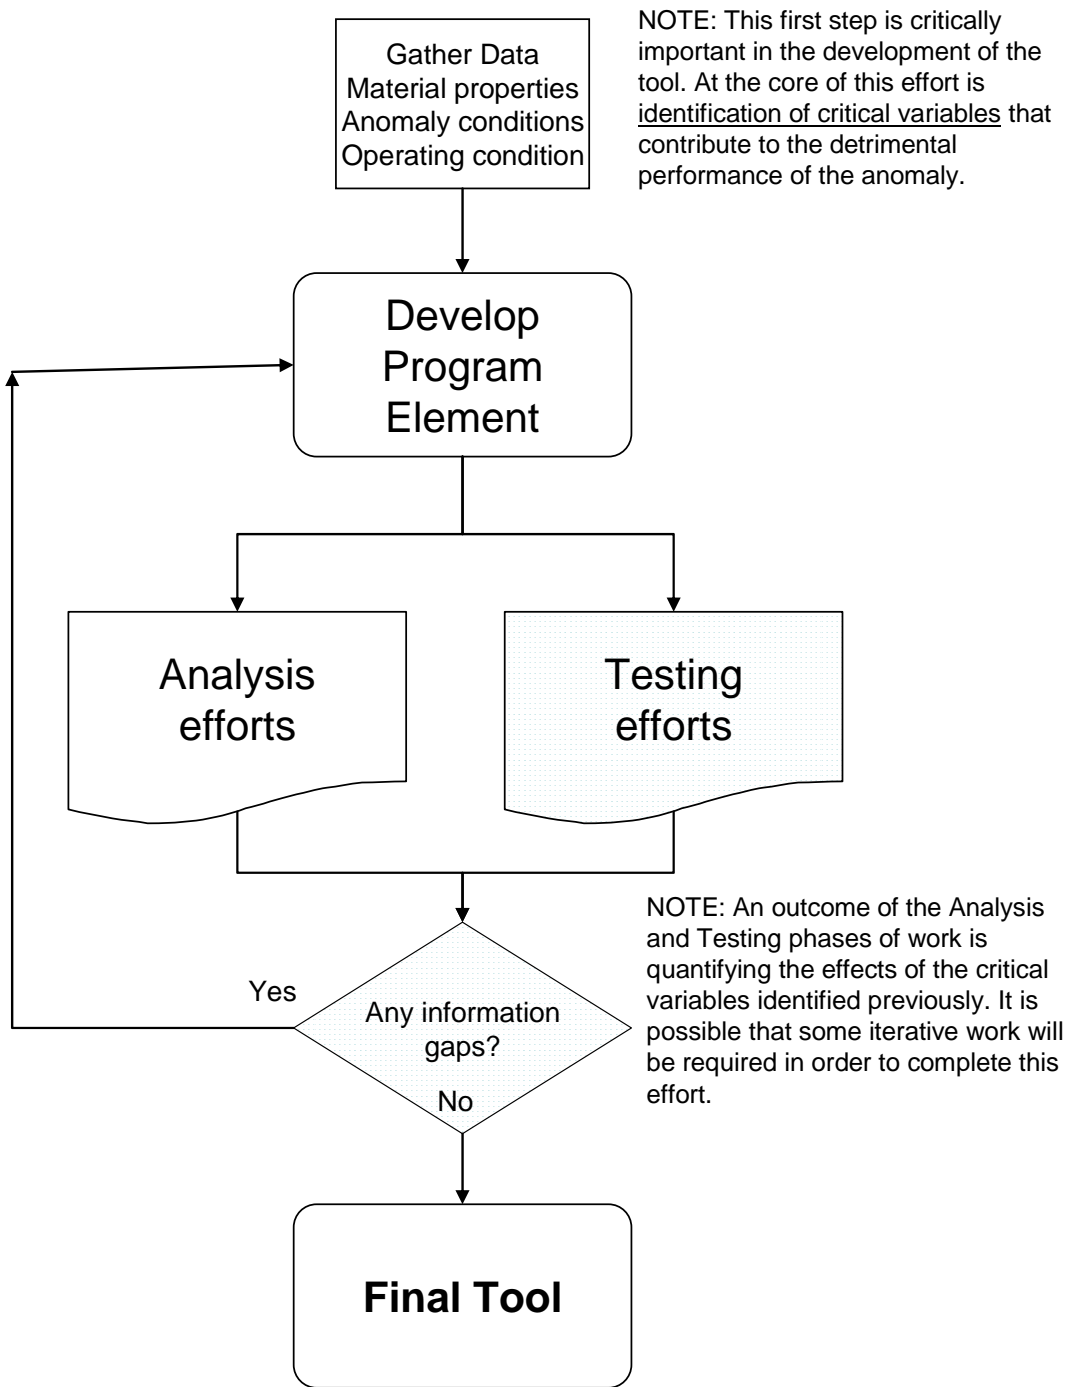
NOTE: The Final Tool should permit the User to input data associated with the critical variables of the anomaly. The tool will then generate information relating to integrity management of the pipeline such as the safe design pressure or fatigue life.

Figure 4 – Flow chart showing stages involved in the development of the EB-IMP assessment tool

Figure 4 is a basic flow chart showing the steps involved in the development of an EB-IMP tool. Note that in this figure the emphasis on identifying and integrating critical variables. As mentioned previously, it is essential when developing a general tool that the critical variables be used as the basis for choosing input parameters. Insights gained during the analysis and testing phases of work will confirm the validity and importance of the previously identified variables. Methods such as the Buckingham-Pi Theorem can be used to generally assess the contribution of a given variable to its effect on pipeline integrity.

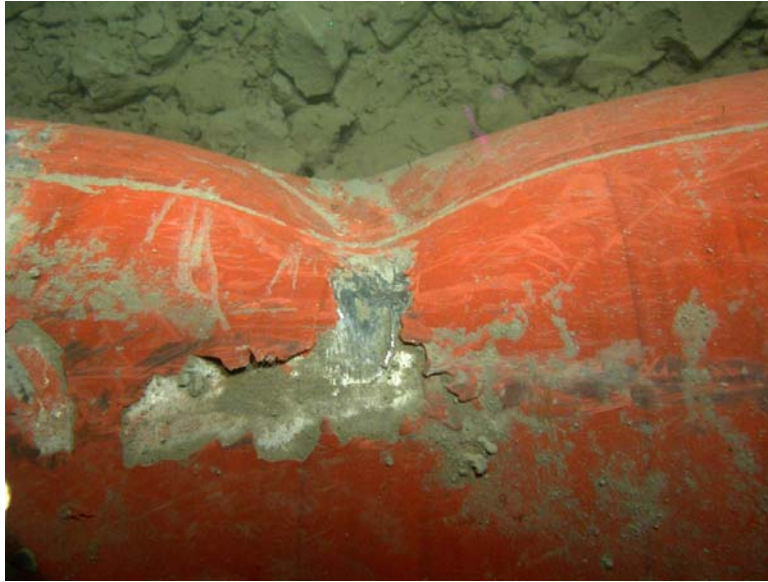
Figure 5 – Photograph of dent in 20-inch Shell URSA gas pipeline [15]

Hurricane Katrina had significant operational impact on the assets in Gulf of Mexico. The Ursa gas pipeline suffered damage presumably from anchor drags. The damage was observed at a water depth of approximately 1000 meters. The pipeline was dented at the longitudinal seam weld (as seen in Figure 5). In addition, the line itself was displaced in the horizontal plane.

operating pressure of the line is 155 Bar (2200 psi), and external pressure is 95 Bar (1350 psi). At time of anchor dragging the line, it was operating at 77.4 Bar (1100 psi). The dent, shown in Figure 5, was in the range of 57 mm to 70 mm. (approximately 2 ¼ - 2 ¾ inches) deep.

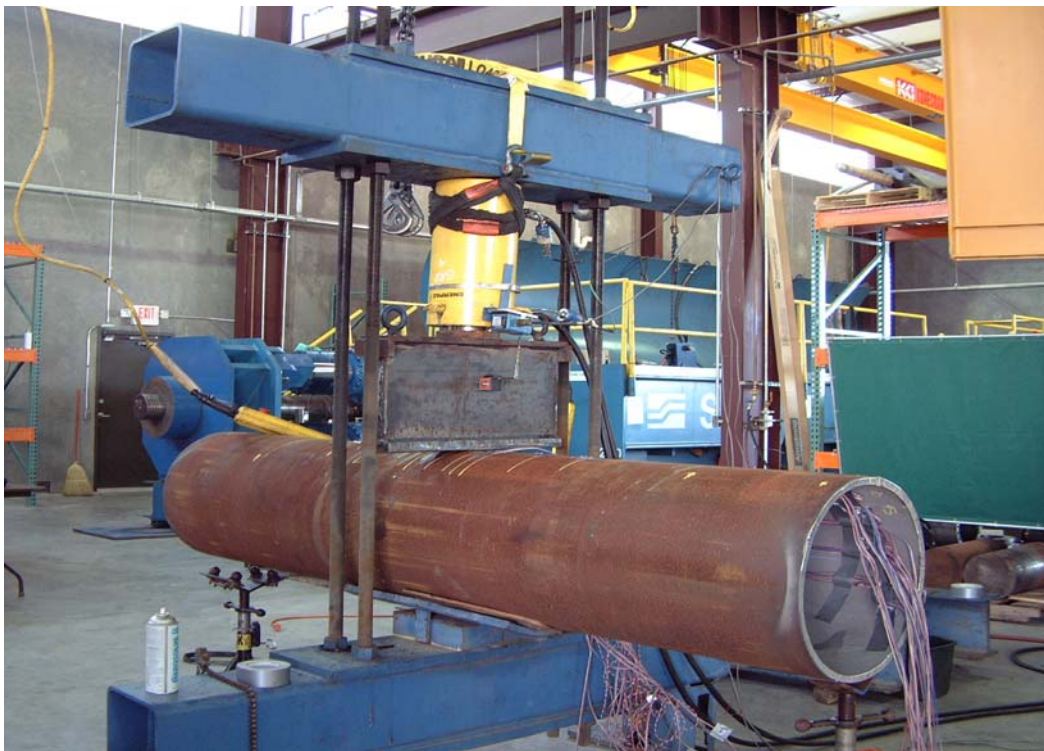
Figure 6 – Photograph of dent installation rig [15]

In order to estimate the future performance of the damaged pipeline, full-scale testing was conducted. Dents were installed in 10-ft long pieces of 20-inch x 0.75-inch, Grade X60 pipe material. Figure 6 shows the dent installation rig that was used to general dents that replicated the actual dent profile [15].

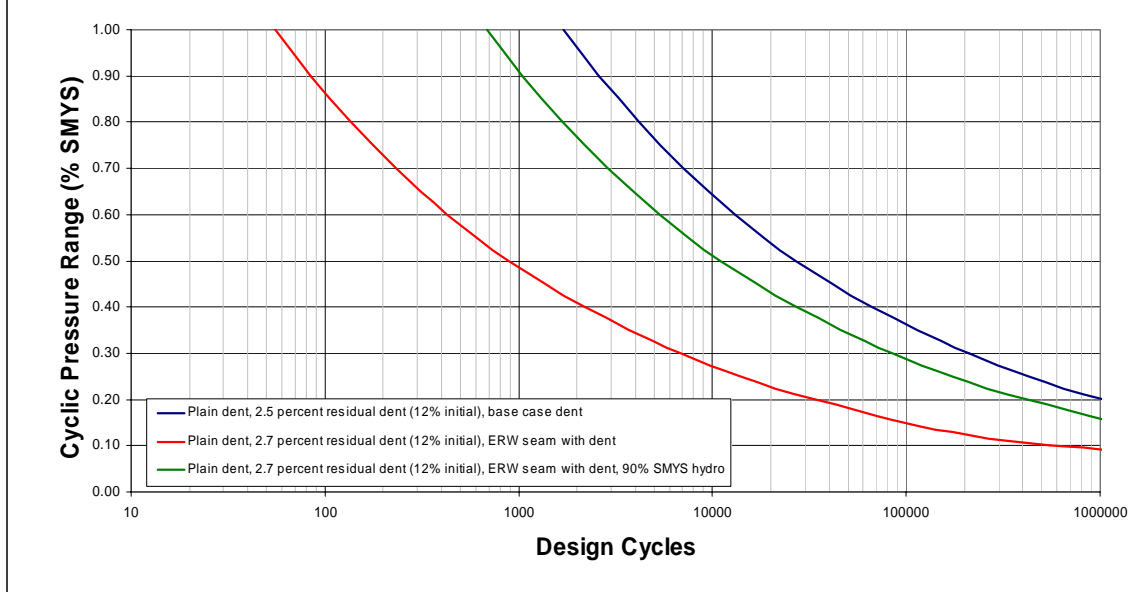
Design Fatigue Life for Plain Dents Subjected to Cyclic Pressure

Data taken from API Publication 1156 involving plain dents in
12.75-in x 0.188-in, Grade X52 pipes subjected to cyclic pressures until failure.

Figure 7 – Fatigue life for plain dents subjected to cyclic pressure

Figure 7 and Table 3 show results for the calculated design fatigue lives for given pipeline imperfections as functions of cyclic pressure and operating conditions.
